**Township of Tiny
Municipal Administration Building
Needs Assessment Report**

R.J. Burnside & Associates Limited
3 Ronell Crescent Collingwood ON L9Y 4J6
and
Ted Handy and Associates Inc., Architect
76 Mary Street, Barrie ON L4N 1T1

May 2014

File No: 300033158.0000

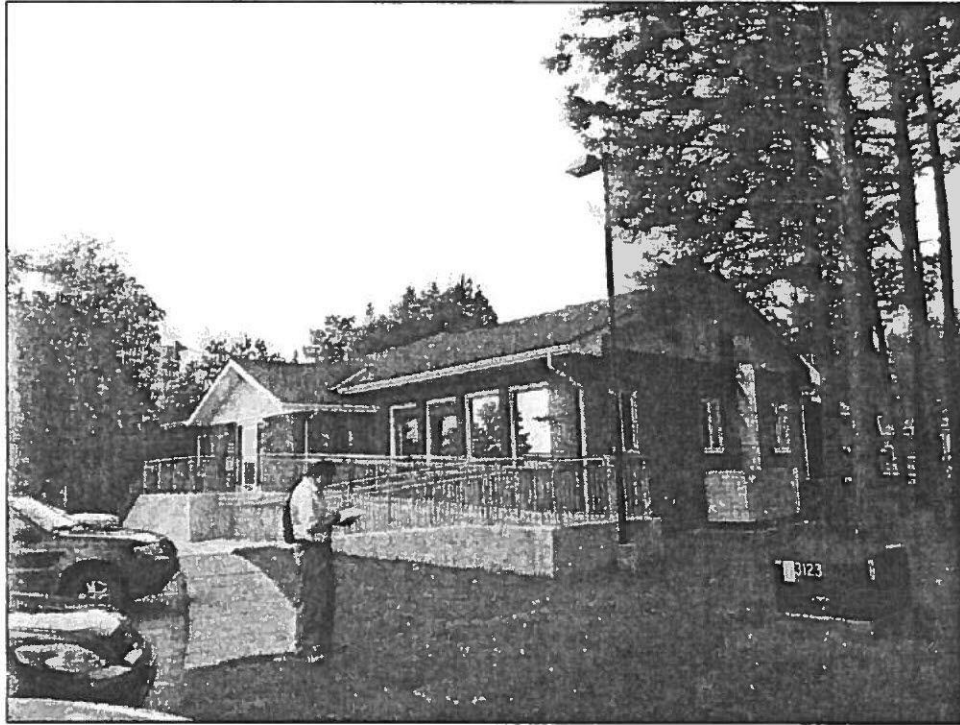
1. Four fixed glass windows and 2 operable windows at the front (south) elevation of the original building require replacement. They appear to be of metal clad wood construction. There was evidence of seal failure and moisture within the air space between panes of glass. The other windows at this face of the building appear to have been recently replaced. See Photo 3, Appendix A.

Photo 3 – Tiny Township Administration Building – South East Corner

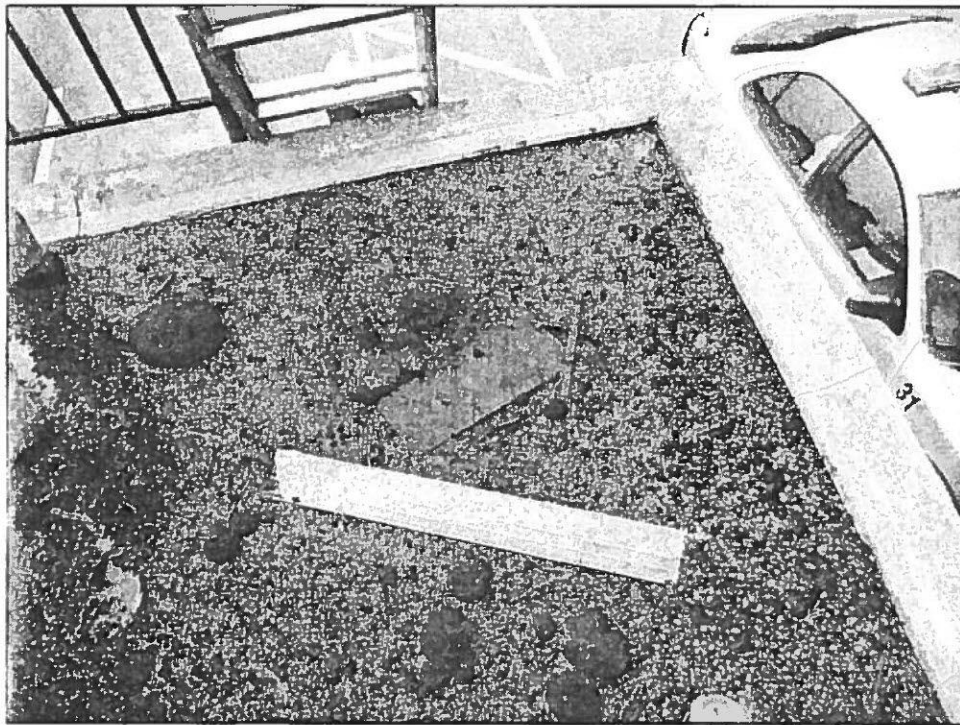
3. The flat roof over the Septic Inspector's office is retaining water and showing signs of organic growth (i.e. moss). Considering its age, this roof will require replacement within 5 years. See Photo 4, Appendix A.

Photo 4 – Flat Roof Over Septic Inspector's Office

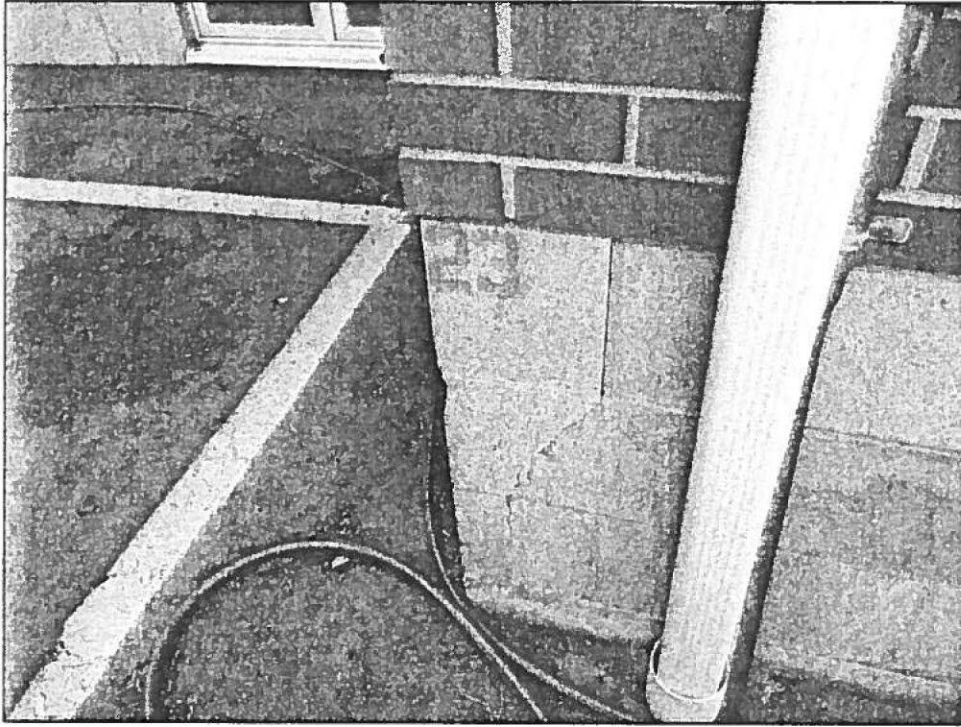
4. The foundation of the original building is of concrete block construction. It is in good condition with no evidence of damage except for the northwest corner where corner spalling has occurred. See Photo 5, Appendix A.

Photo 5 – Corner Spalling at Foundation of the Original Building

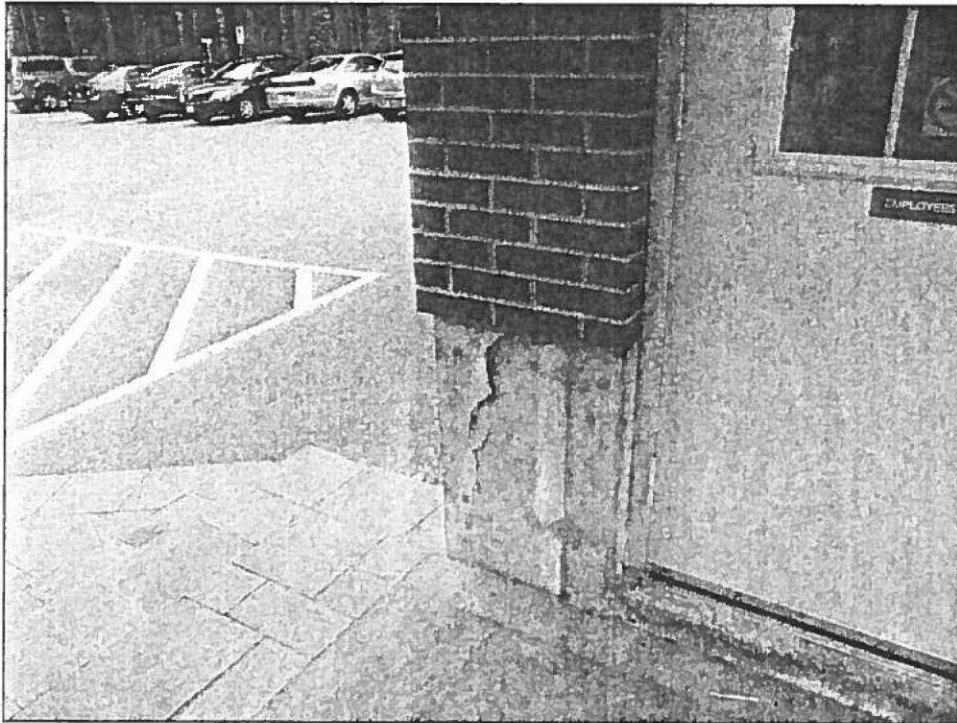
5. The foundation of the addition is of cast-in-place concrete construction. It is in very good condition with no evidence of damage except for localized spalling at the northeast corner of the addition and minor cracking at the side of one basement window on the west wall. See Photos 6 and 7, Appendix A.

Photo 6 – Corner Spalling on Southeast Corner on Addition Foundation

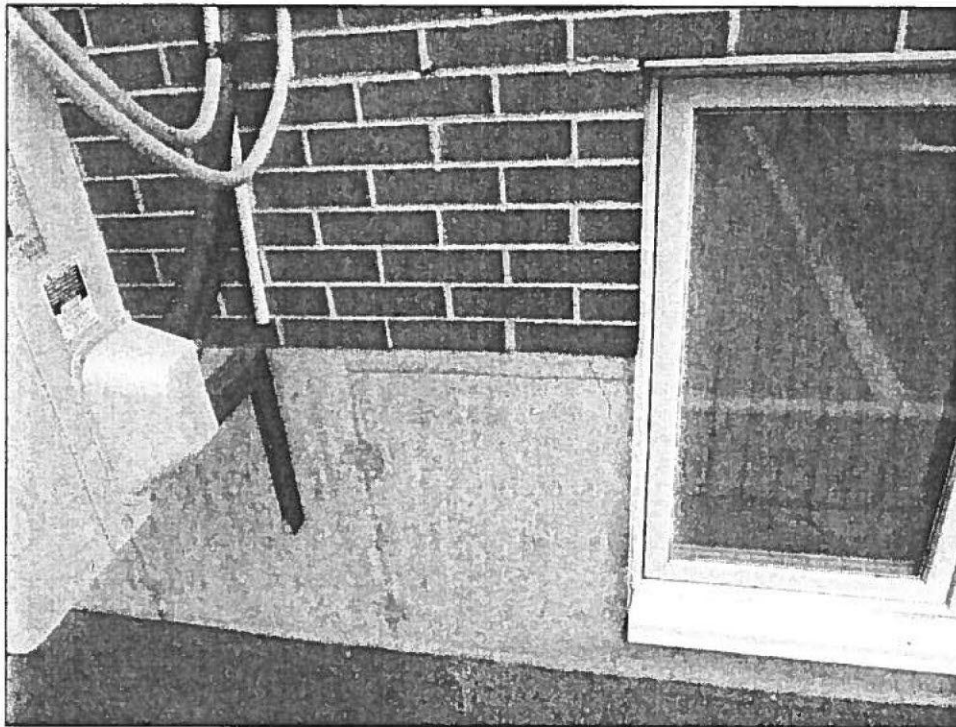
Photo 7 – Minor Cracking Beside One Basement Window on North side of Addition

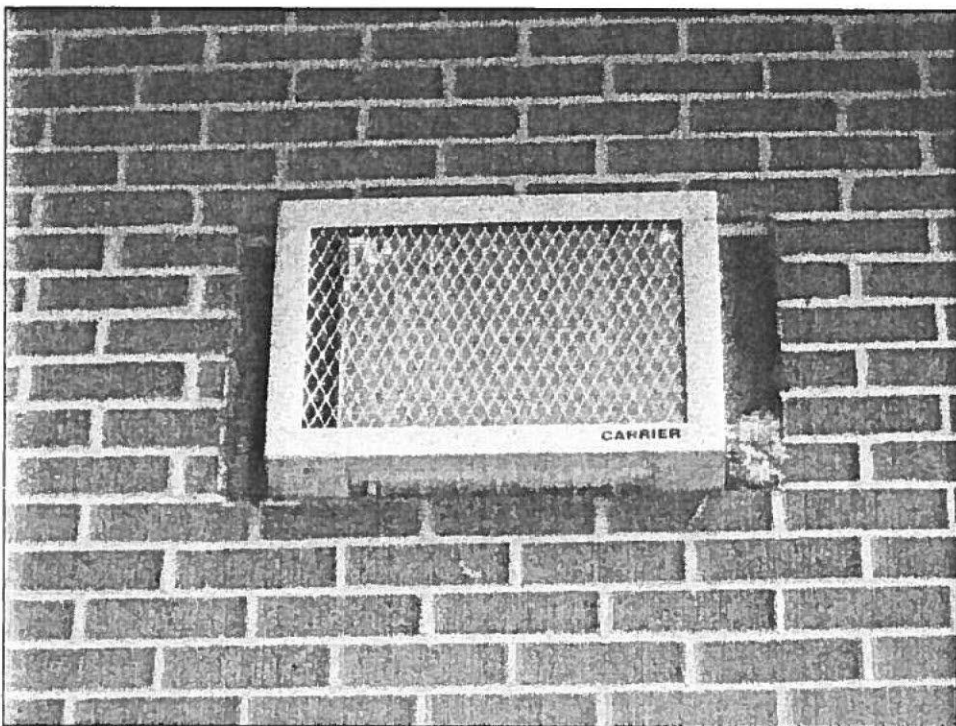
6. There is an oversized opening at the ground floor air conditioning unit near the northwest corner of the addition. The opening requires infilling to prevent entry of precipitation, birds, insects, etc. See Photo 8, Appendix A.

Photo 8 – Oversized Opening at Ground Floor AC Near Northeast Corner of Addition

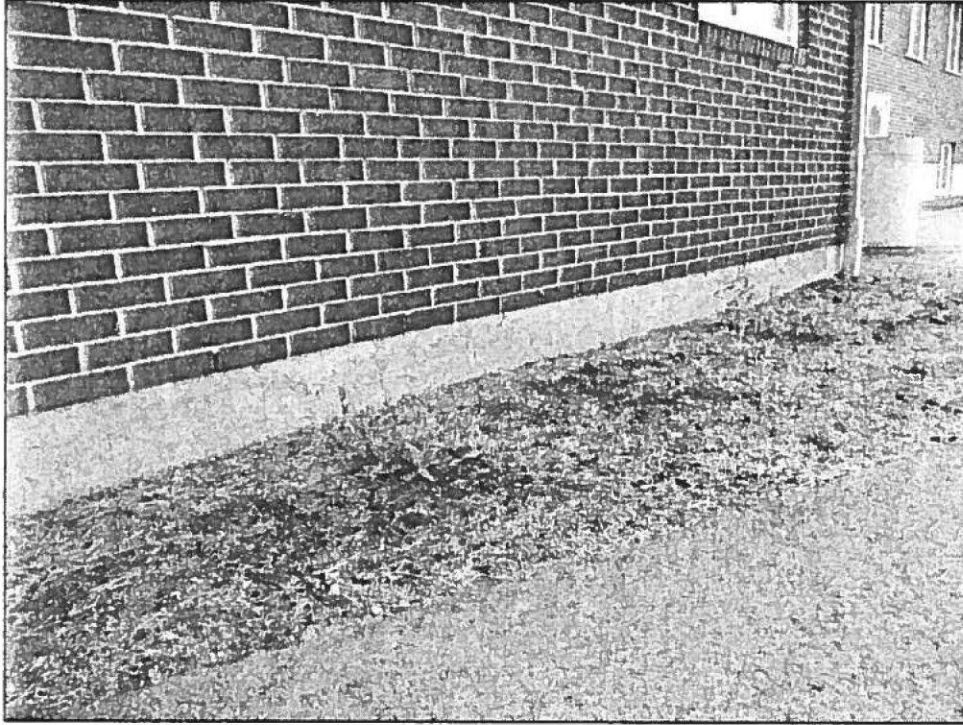
7. There is an Entrance Lobby at the northeast corner of the addition which provides barrier free access to the lower level Council Chamber. The foundation is of concrete block construction and shows evidence of cracking at the top course head joints in the mortar. See Photo 9, Appendix A.

Photo 9 – Cracking at Top Course Head Joints of Concrete Block Foundation, Entrance Lobby at Northeast Corner of Addition

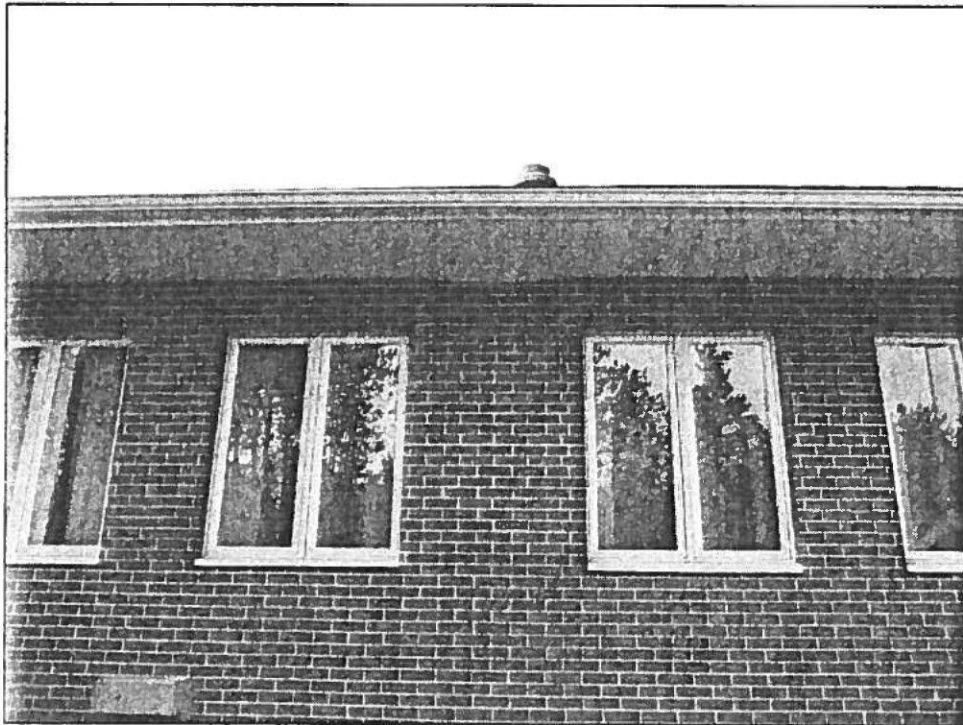
8. There is a 3 foot section of damaged soffit at the east side of the addition. See Photo 10, Appendix A.
9. The finished grade along some sections of the original building foundation is above the level of the bricks. Although this is not good construction practice, there are no signs of damage to the brick.

Photo 10 – Three Foot Section of Damages Soffit at South Side of the Addition

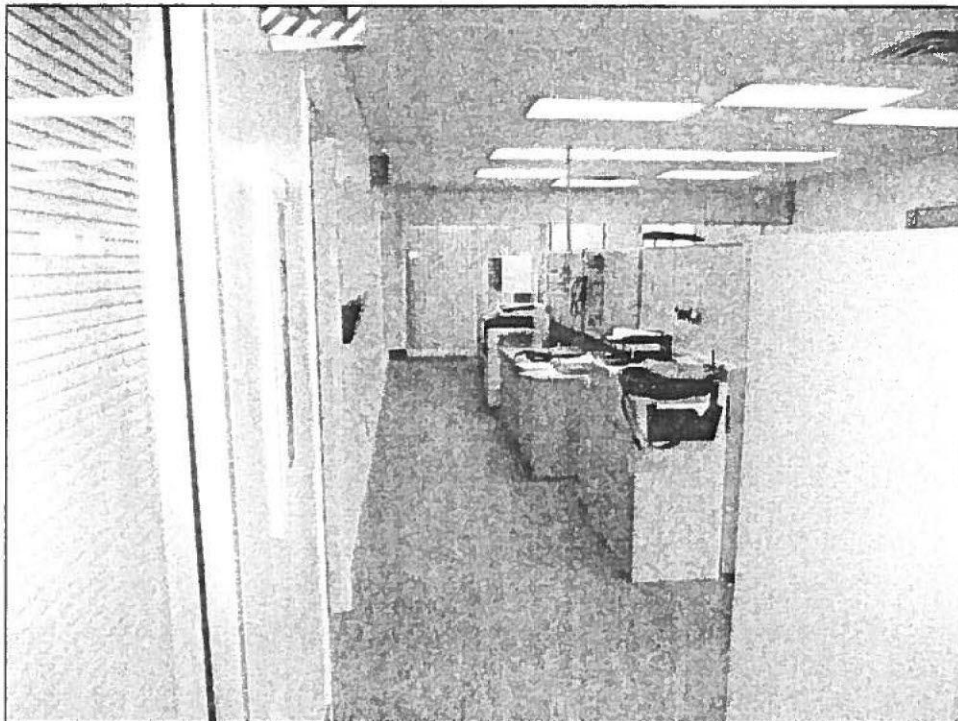
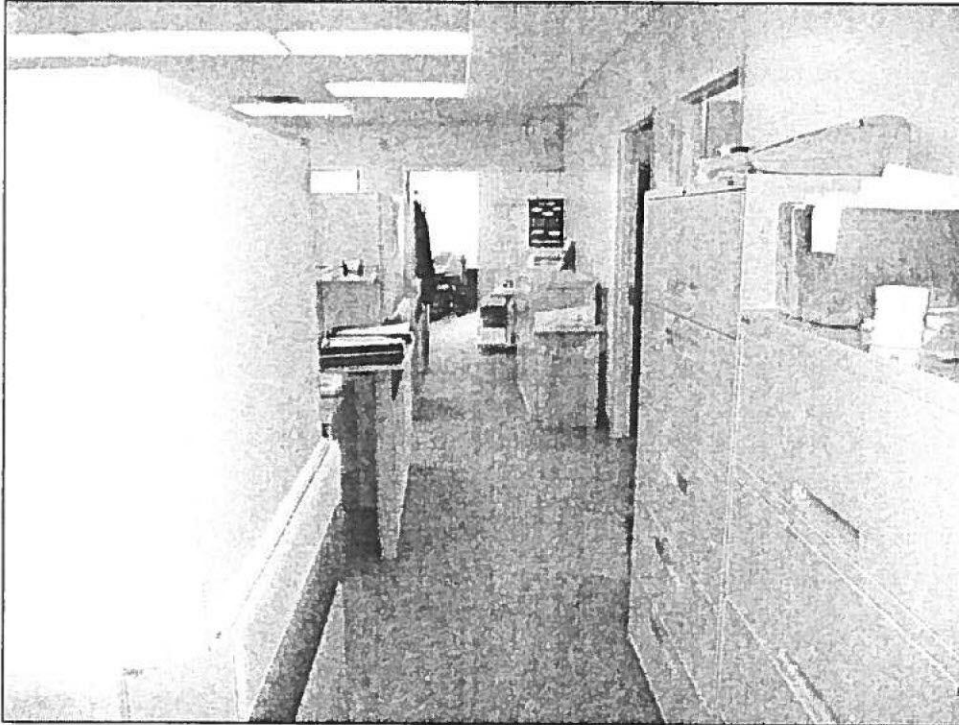
Photo 12 – The Location of Filing Cabinets in Corridor Areas is Such that They Infringe on Floor Space, Which Hampers the Operation of the Facility

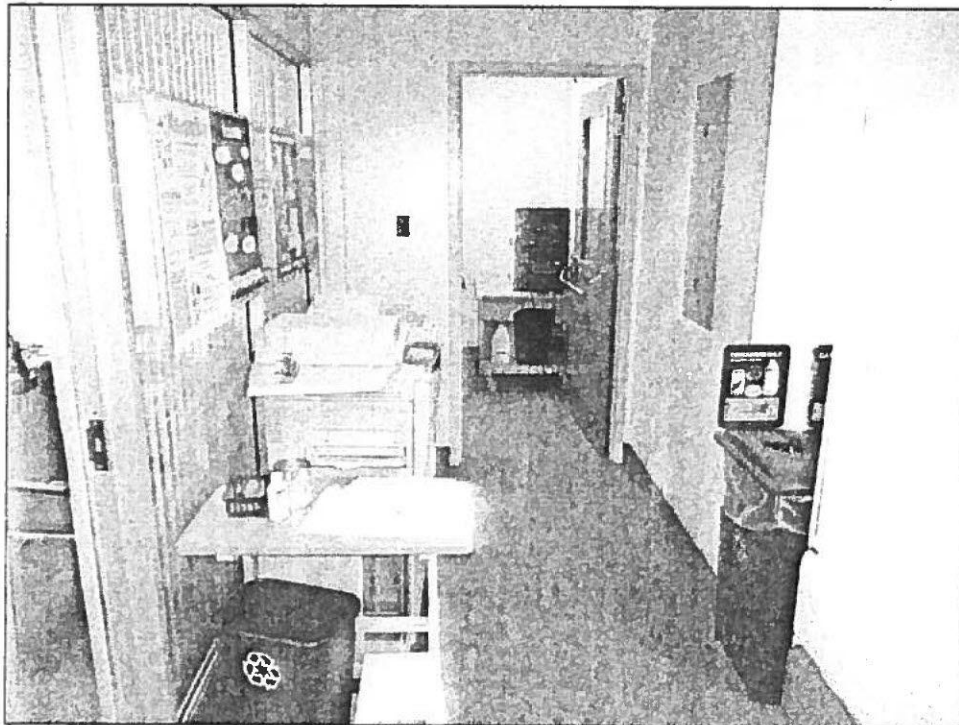
Photo 14 – The Location of Communal Printers and Correlation Services are Not Well Related to Users and Also Affects Means of Egress

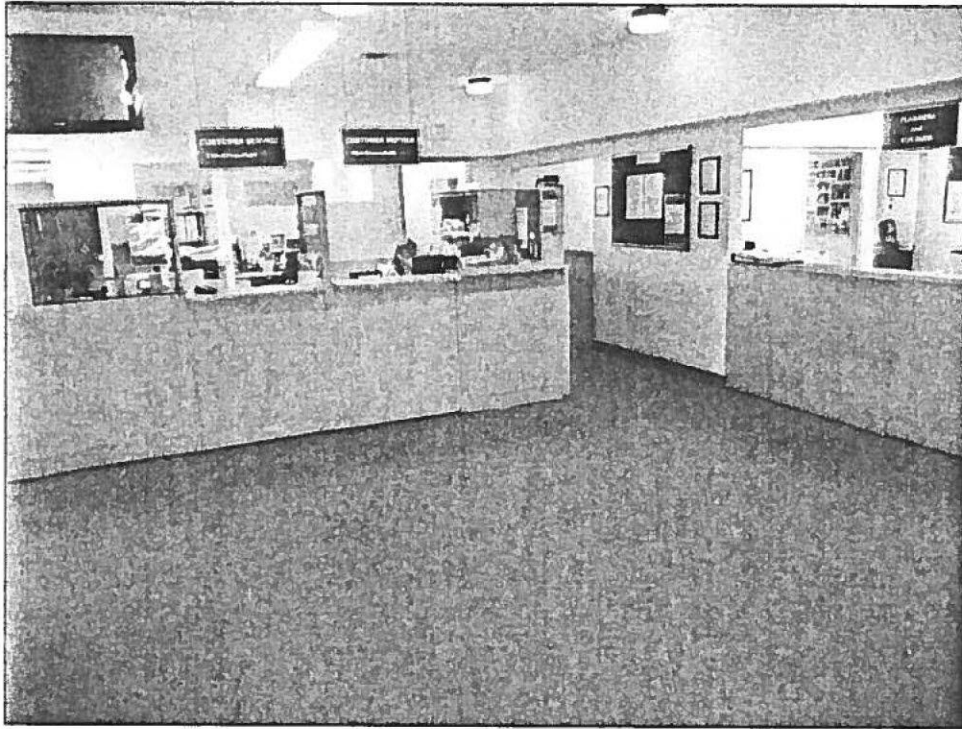
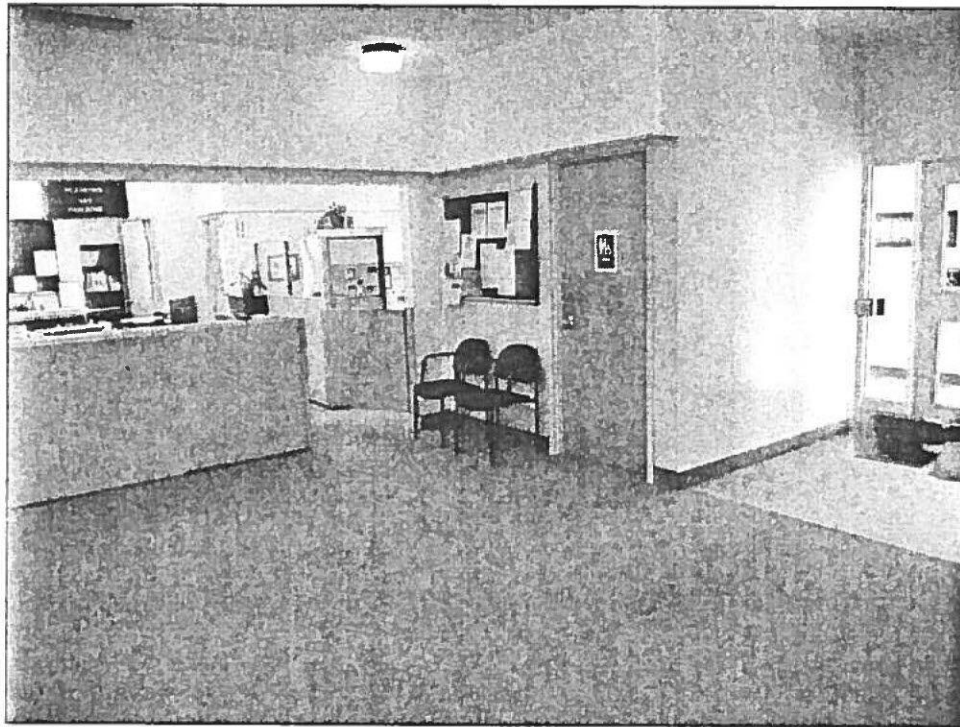
Photo 15 – The Image and Function of the Reception Area is Compromised and There is No Sense of a Public Lobby

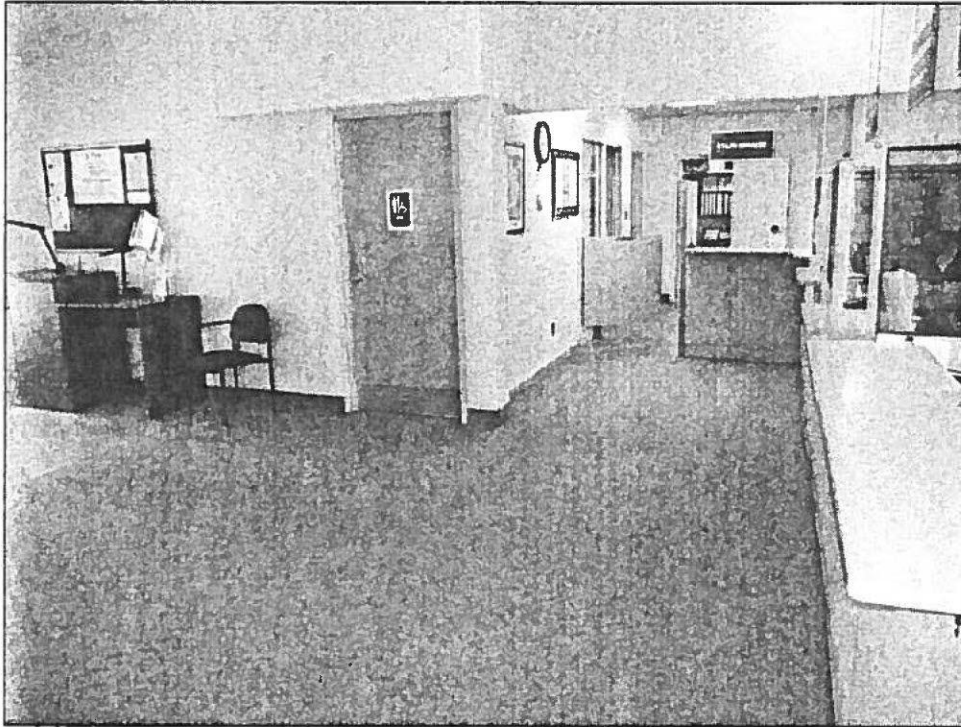
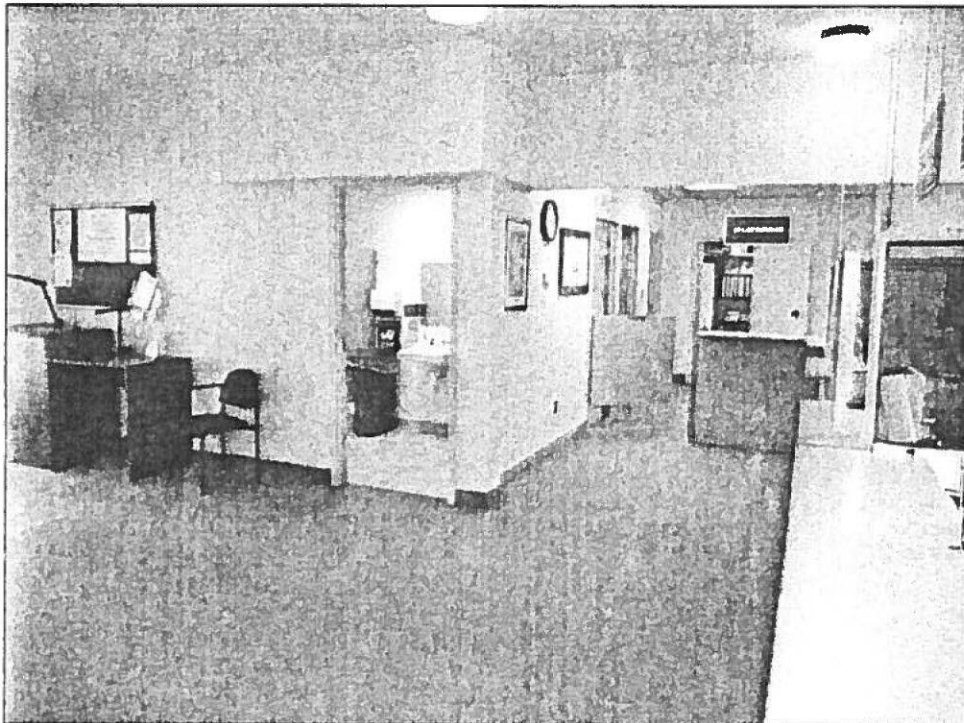
Photo 17 – The Public Washrooms are Located Too Close to the Front Counter

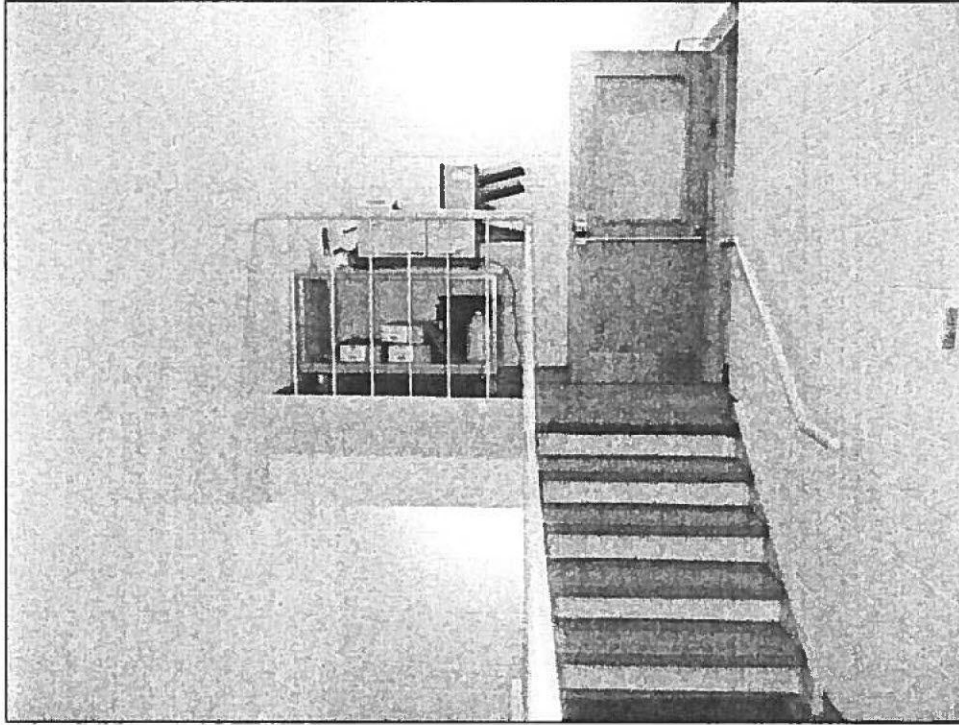
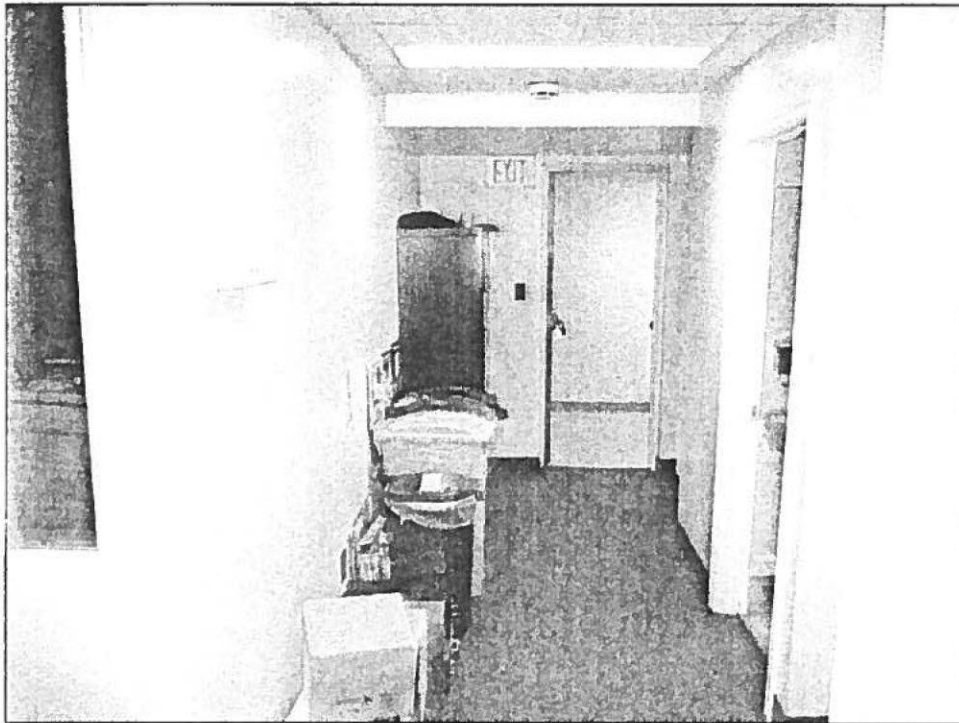
16. Building security is compromised with no barriers or impediments to prevent public from wandering through the building.
17. Due to lack of functional and storage space, corridors are used for active functions such as cheque processing and become repositories of combustible material representing a fire and exiting hazard (see photos 19 and 20).
18. Parking areas (4) are disjointed and at certain key times are insufficient to meet need.

Photo 19 – Due to Lack of Functional Storage Space, Corridors are Used For Active Functions
