Township of Tiny Municipal Administration Building

Needs Assessment Report

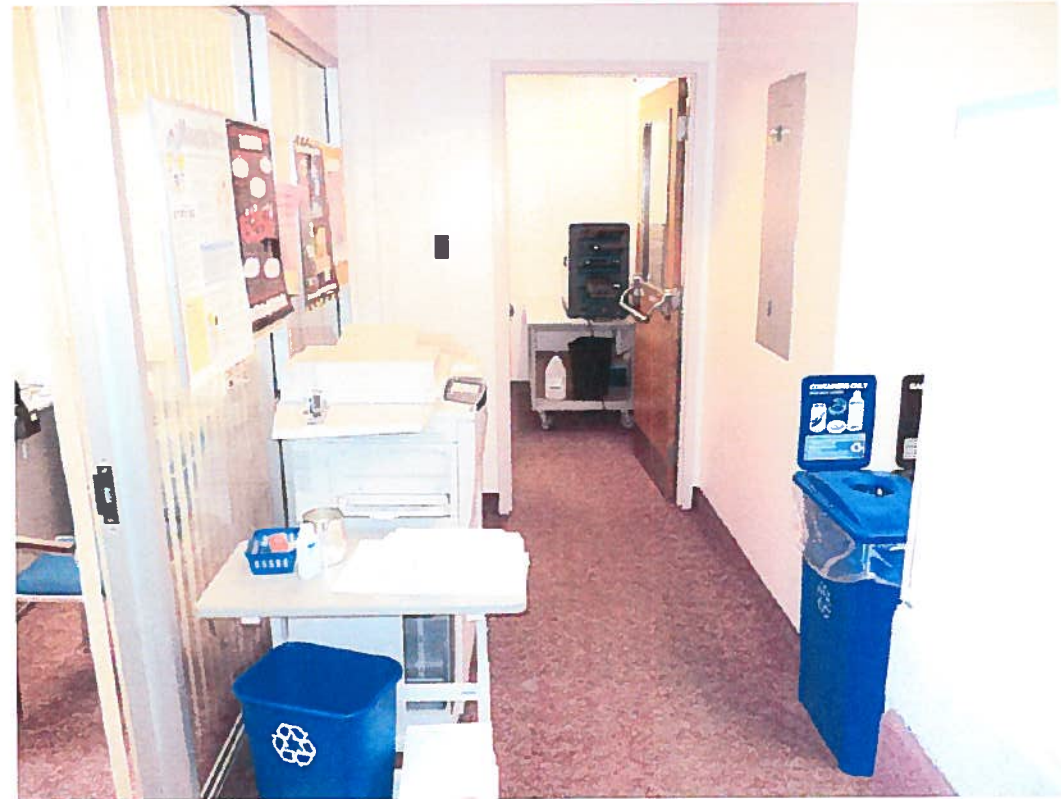
6. Location of communal printers and correlation services not well related to users and effects means of egress
7. Difficulty booking meeting rooms during tax and other high-use times

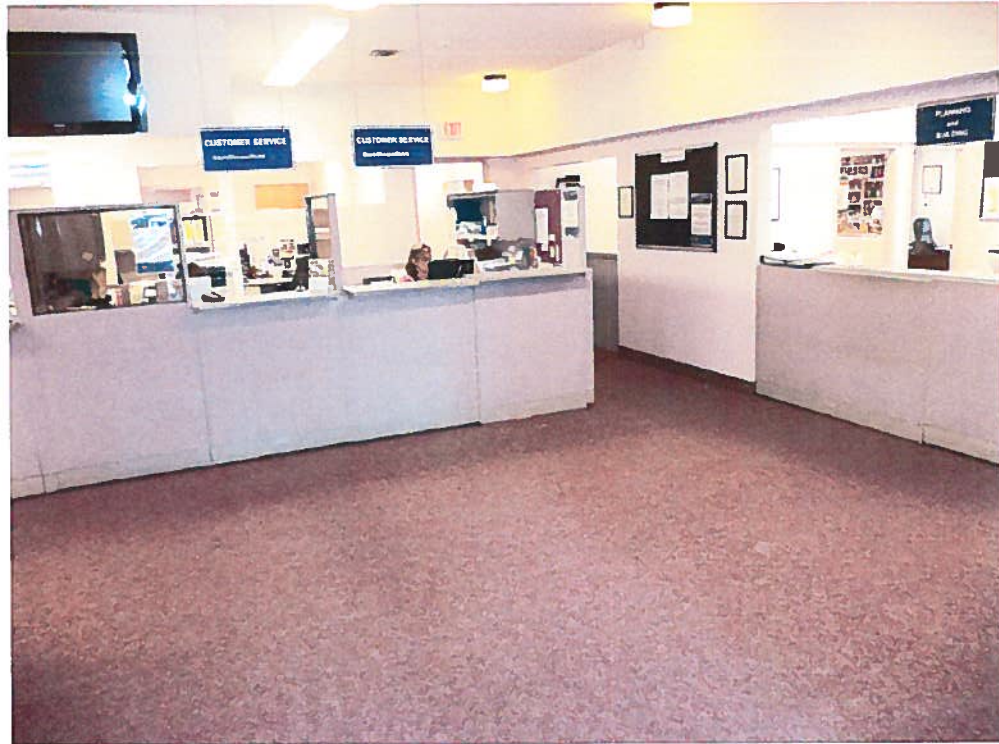
8. Reception area: no sense of public lobby, confusion for users, no space for display of public information, not connected to related departments
9. Key departments, such as Fire Department and Roads / Parks / Superintendent offices are located in remote, off-site locations

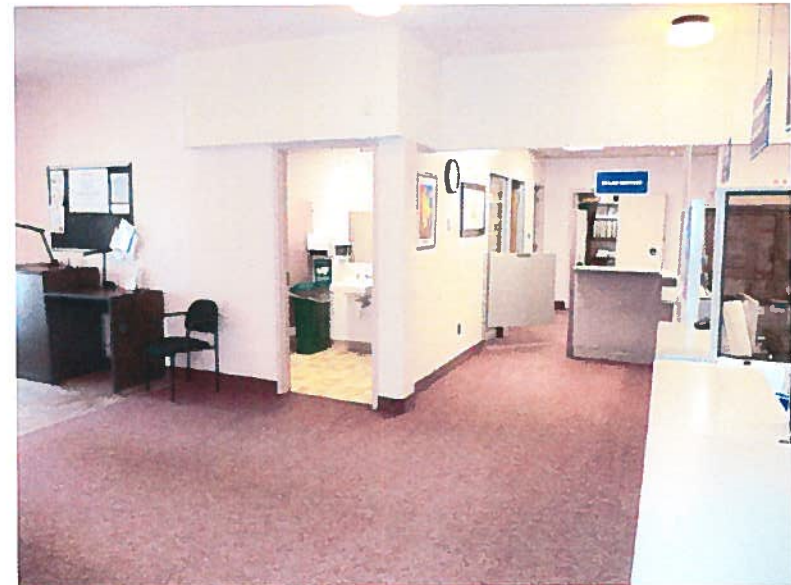
10. Location of Council Chamber in basement is not prominent, difficult to find, lacks lobby and washroom facilities
11. Separate entrances, accessibility difficult to address in existing building
12. Administrative assistants' offices lack privacy for discussing sensitive matters
13. Public washrooms are located too close to front counter

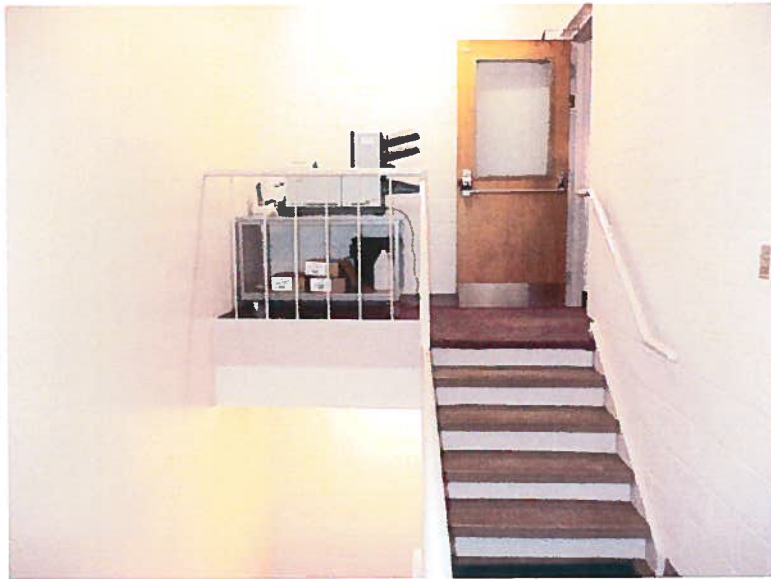
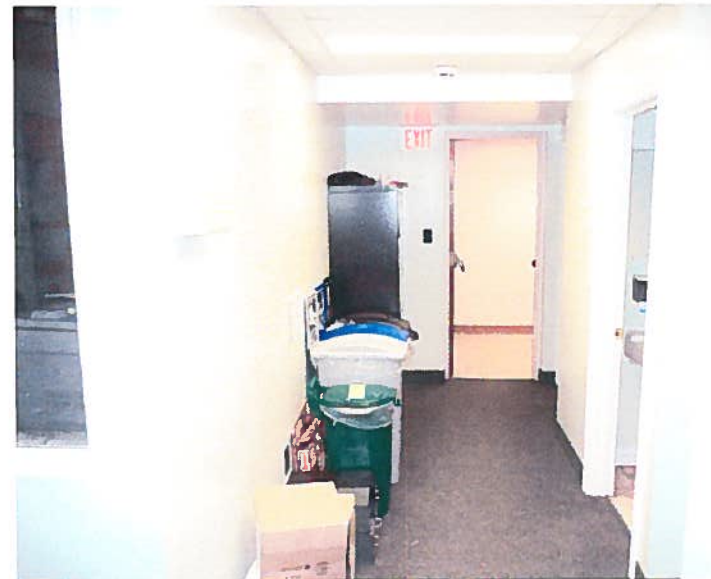
17. Corridors are used for active functions, become repositories for combustible material due to lack of functional / storage space
18. Parking areas are disjointed and inefficient to meet current needs

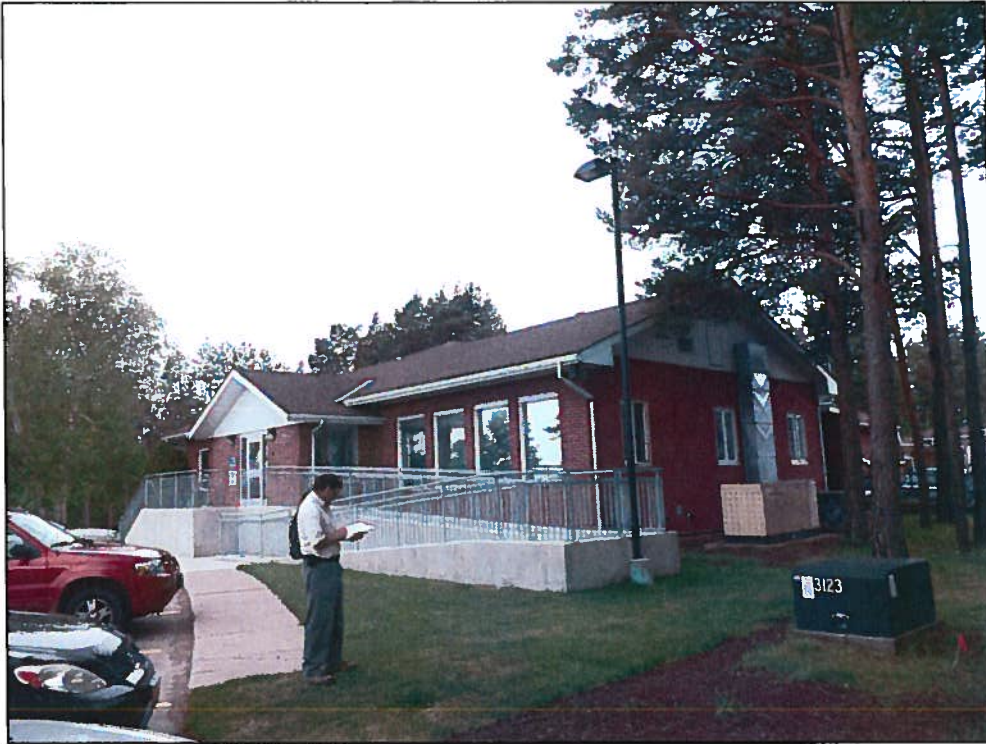
1. Four fixed glass windows and 2 operable windows at the front (south) elevation of the original building require replacement. They appear to be of metal clad wood construction. There was evidence of seal failure and moisture within the air space between panes of glass. The other windows at this face of the building appear to have been recently replaced. See Photo 3, Appendix A.

Photo 3 – Tiny Township Administration Building – South East Corner

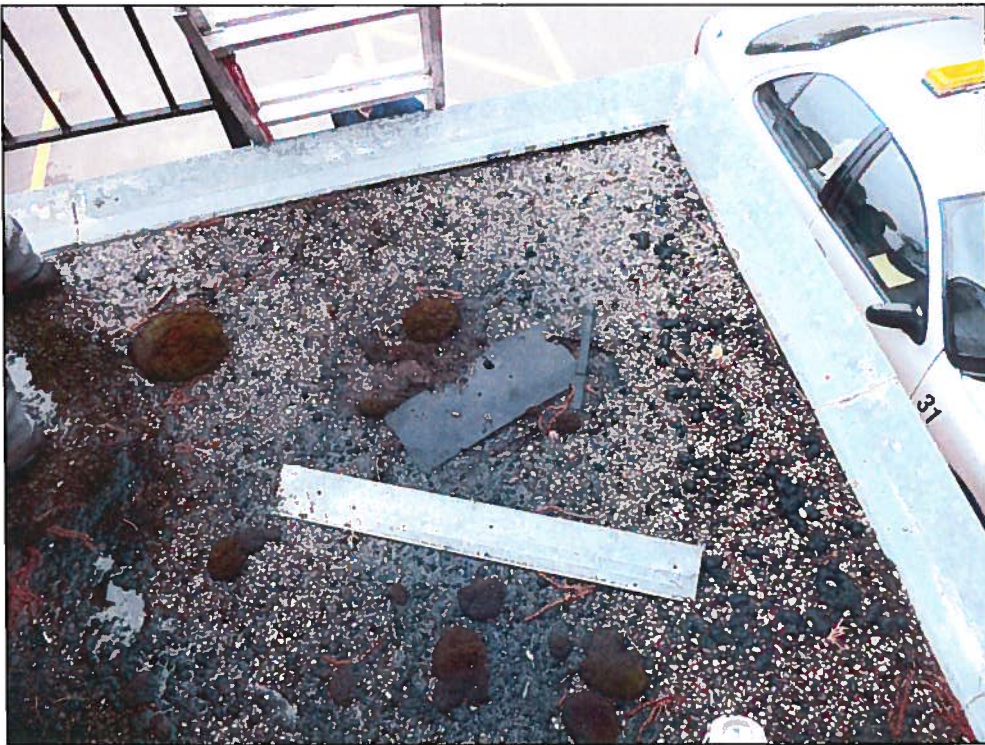
3. The flat roof over the Septic Inspector's office is retaining water and showing signs of organic growth (i.e. moss). Considering its age, this roof will require replacement within 5 years. See Photo 4, Appendix A.

Photo 4 – Flat Roof Over Septic Inspector's Office

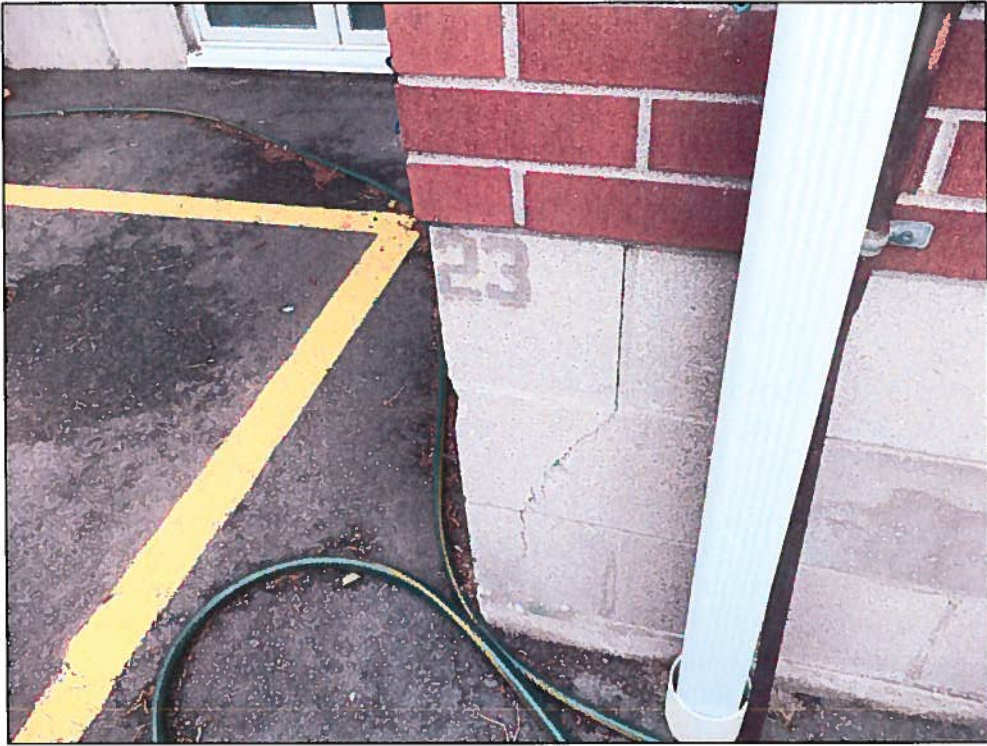
4. The foundation of the original building is of concrete block construction. It is in good condition with no evidence of damage except for the northwest corner where corner spalling has occurred. See Photo 5, Appendix A.

Photo 5 – Corner Spalling at Foundation of the Original Building

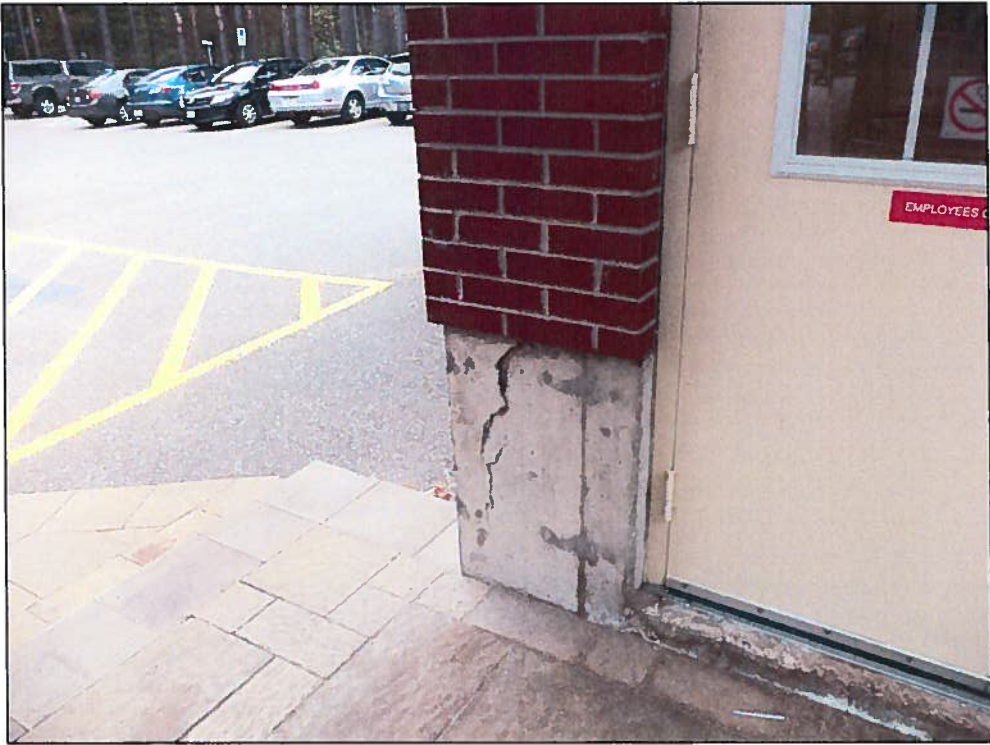
5. The foundation of the addition is of cast-in-place concrete construction. It is in very good condition with no evidence of damage except for localized spalling at the northeast corner of the addition and minor cracking at the side of one basement window on the west wall. See Photos 6 and 7, Appendix A.

Photo 6 – Corner Spalling on Southeast Corner on Addition Foundation

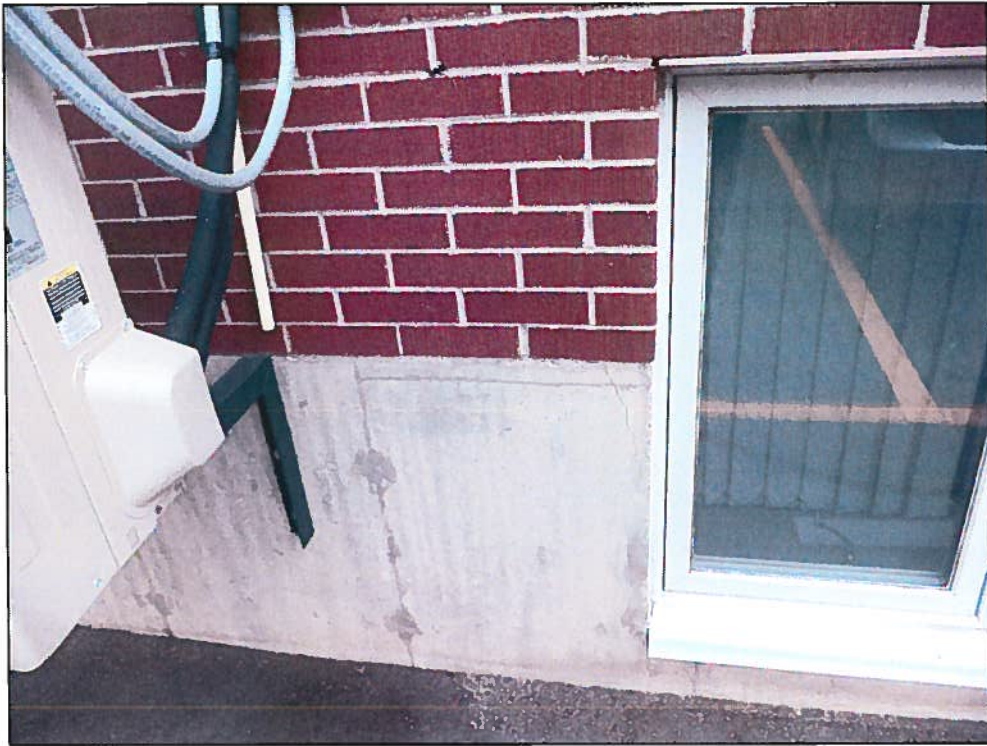
Photo 7 – Minor Cracking Beside One Basement Window on North side of Addition

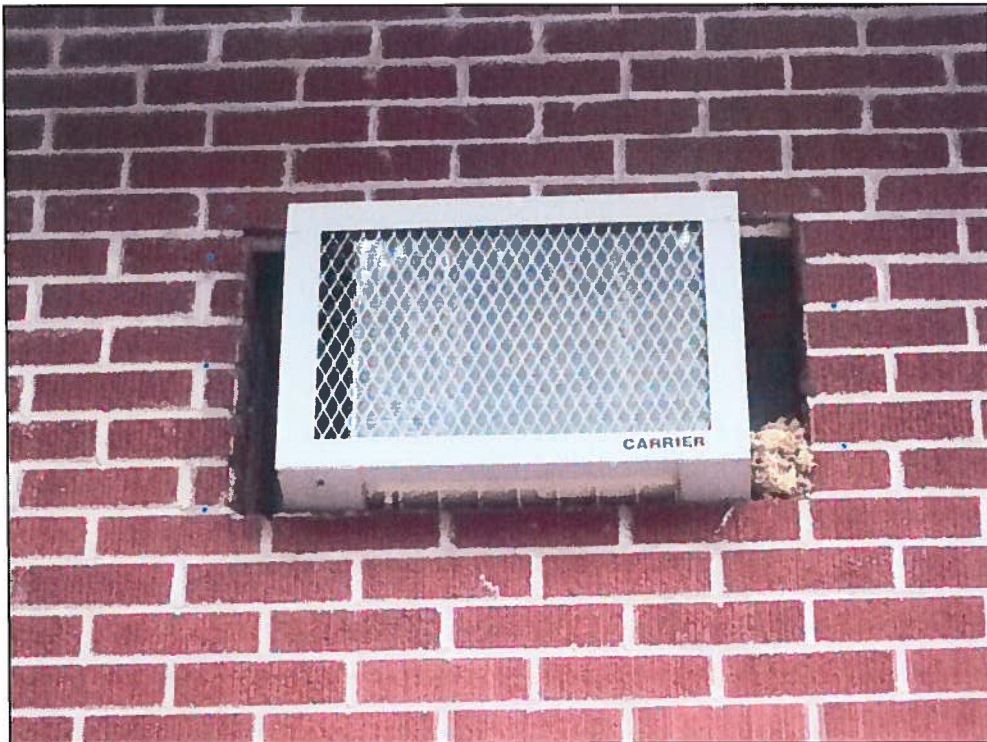
6. There is an oversized opening at the ground floor air conditioning unit near the northwest corner of the addition. The opening requires infilling to prevent entry of precipitation, birds, insects, etc. See Photo 8, Appendix A.

Photo 8 – Oversized Opening at Ground Floor AC Near Northeast Corner of Addition

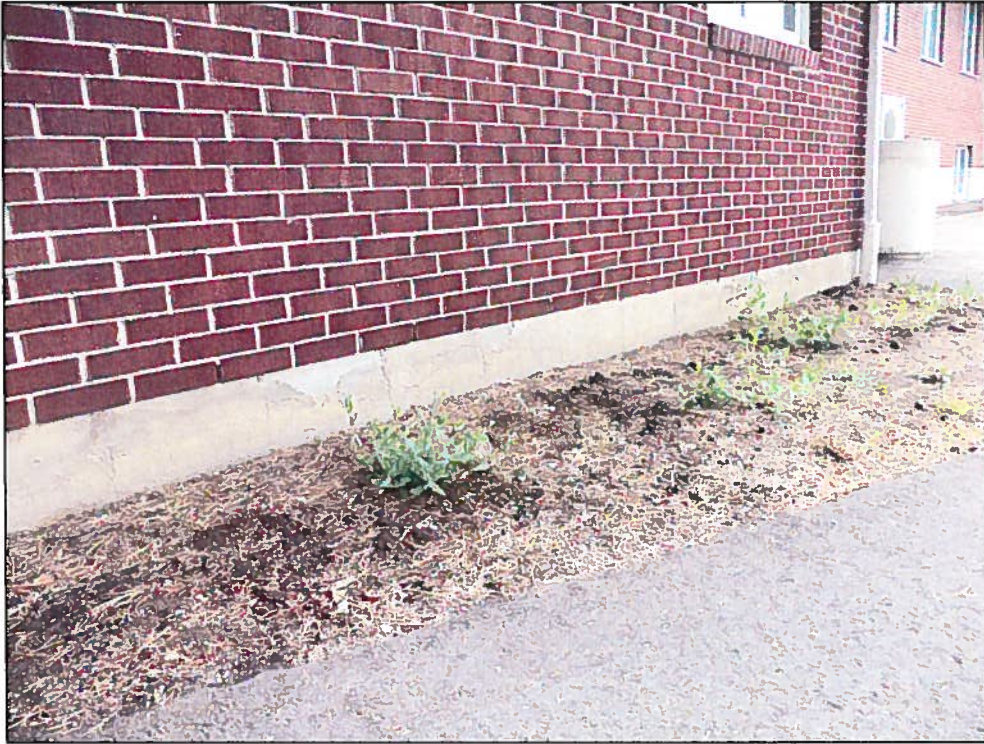
7. There is an Entrance Lobby at the northeast corner of the addition which provides barrier free access to the lower level Council Chamber. The foundation is of concrete block construction and shows evidence of cracking at the top course head joints in the mortar. See Photo 9, Appendix A.

Photo 9 – Cracking at Top Course Head Joints of Concrete Block Foundation, Entrance Lobby at Northeast Corner of Addition

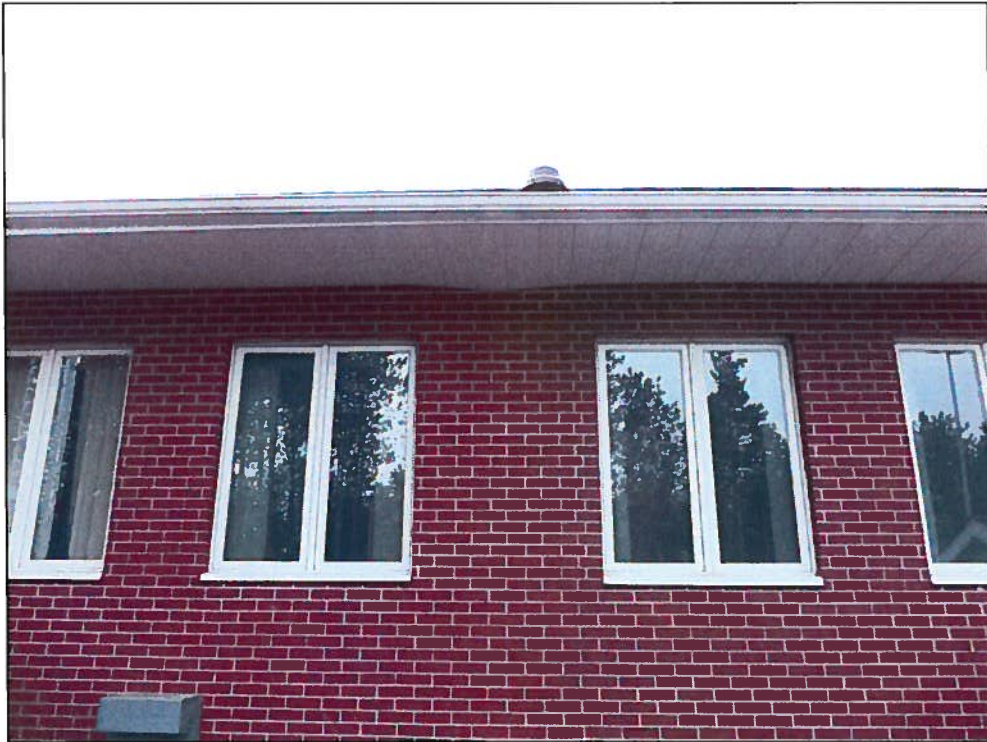
8. There is a 3 foot section of damaged soffit at the east side of the addition. See Photo 10, Appendix A.
9. The finished grade along some sections of the original building foundation is above the level of the bricks. Although this is not good construction practice, there are no signs of damage to the brick.

Photo 10 – Three Foot Section of Damages Soffit at South Side of the Addition

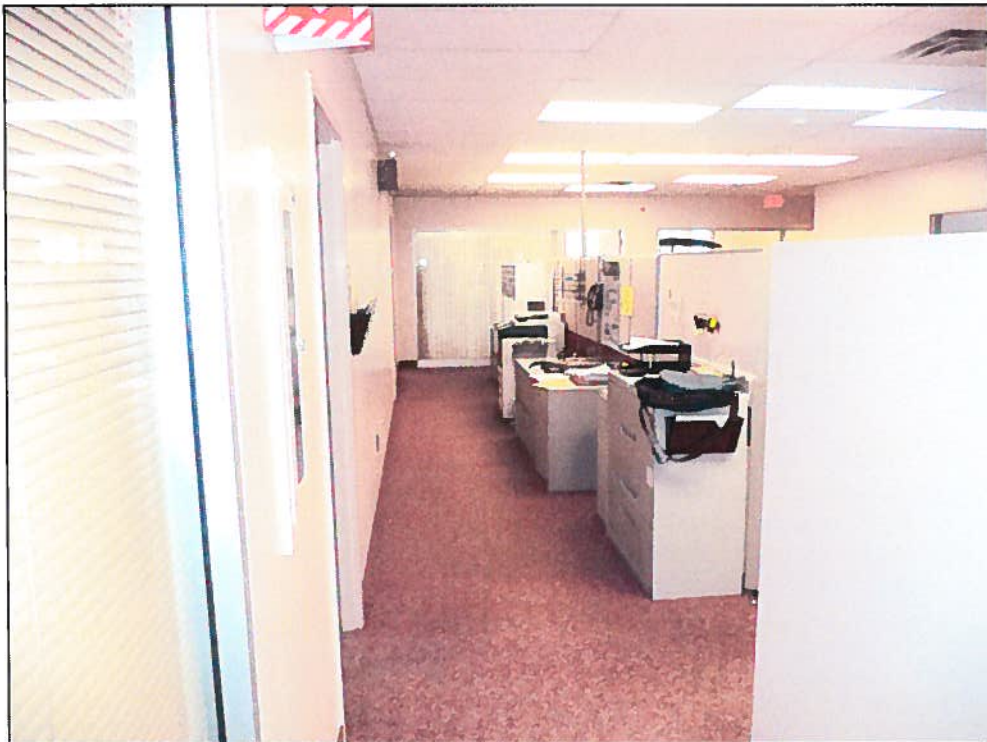
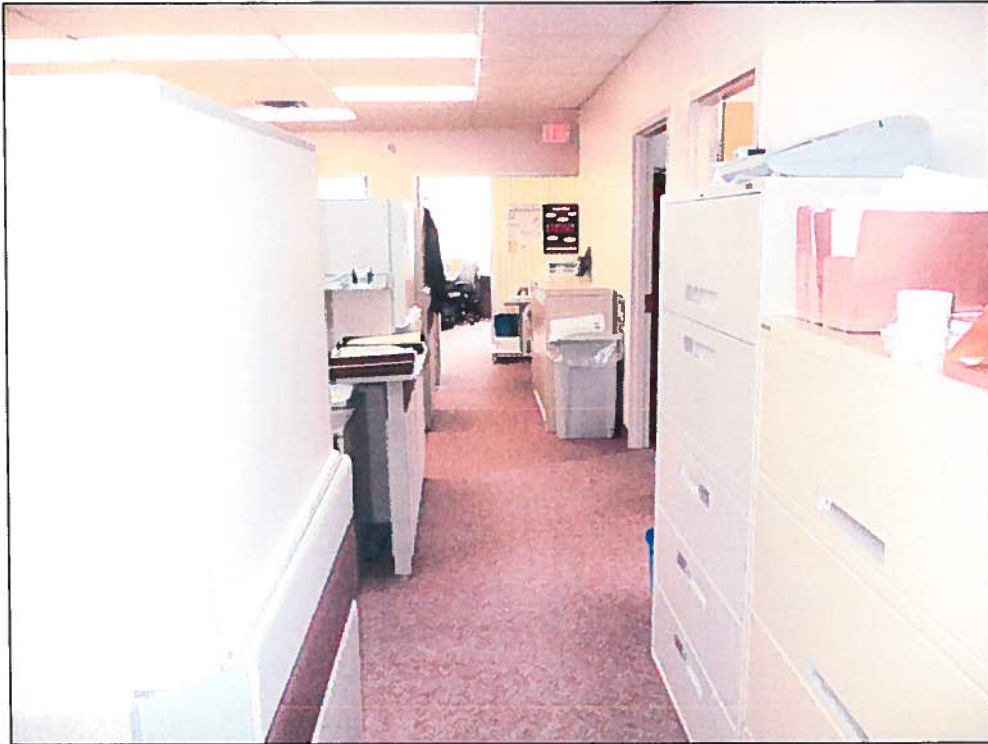
Photo 12 – The Location of Filing Cabinets in Corridor Areas is Such that They Infringe on Floor Space, Which Hampers the Operation of the Facility

Photo 13 – The Location of Filing Cabinets in Corridor Areas is Such that They Infringe on Floor Space, Which Hampers the Operation of the Facility

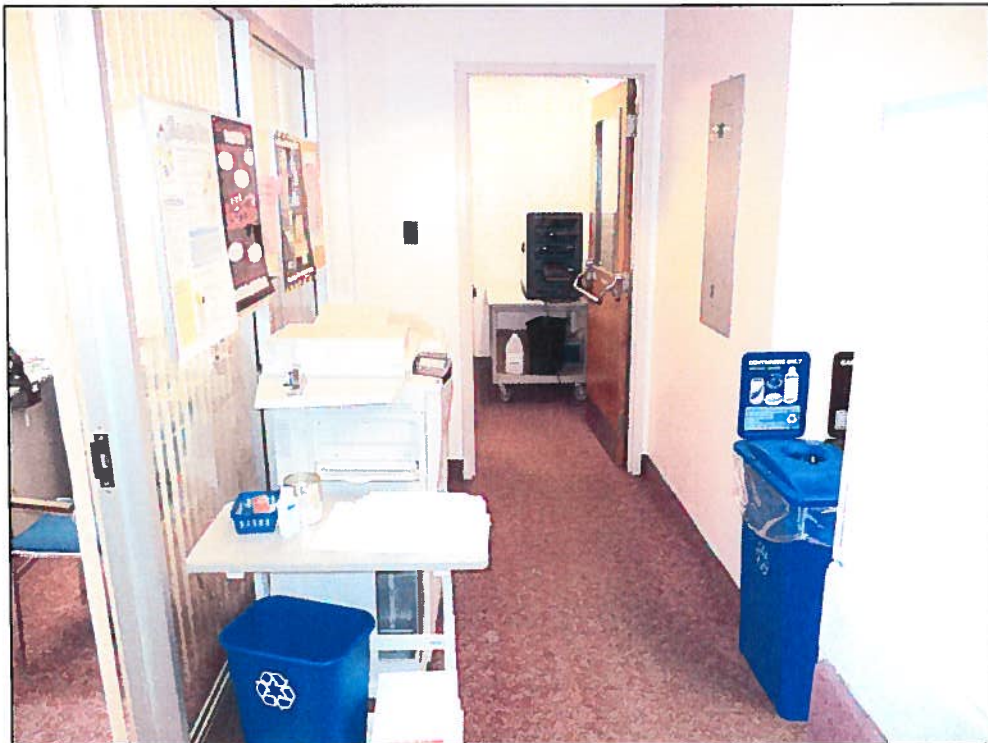
Photo 14 – The Location of Communal Printers and Correlation Services are Not Well Related to Users and Also Affects Means of Egress

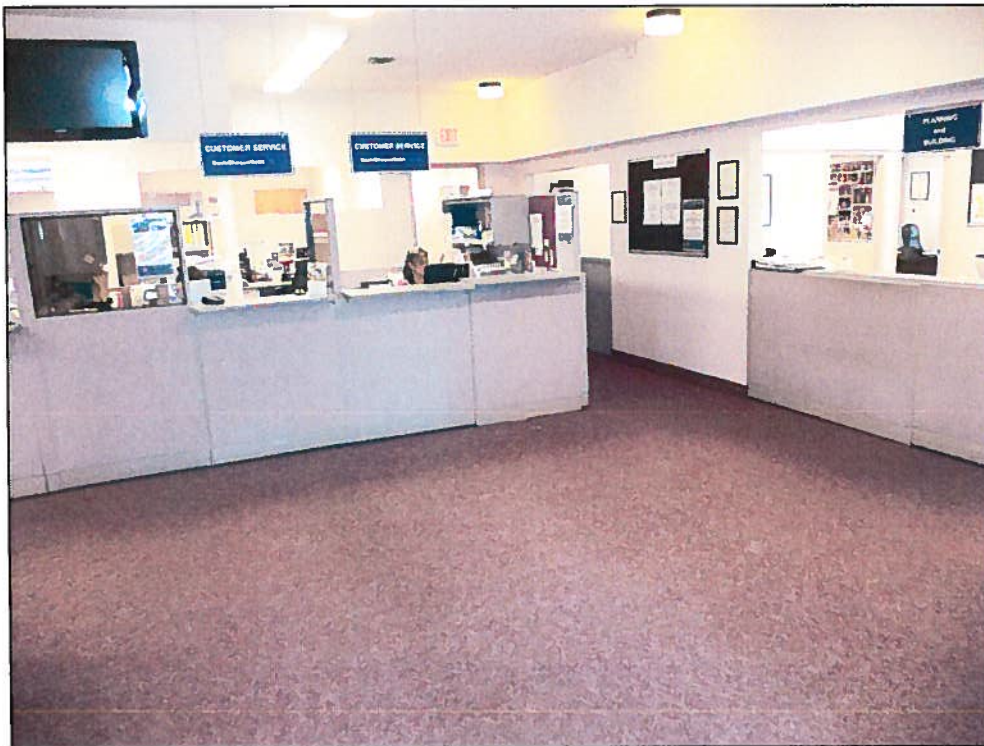
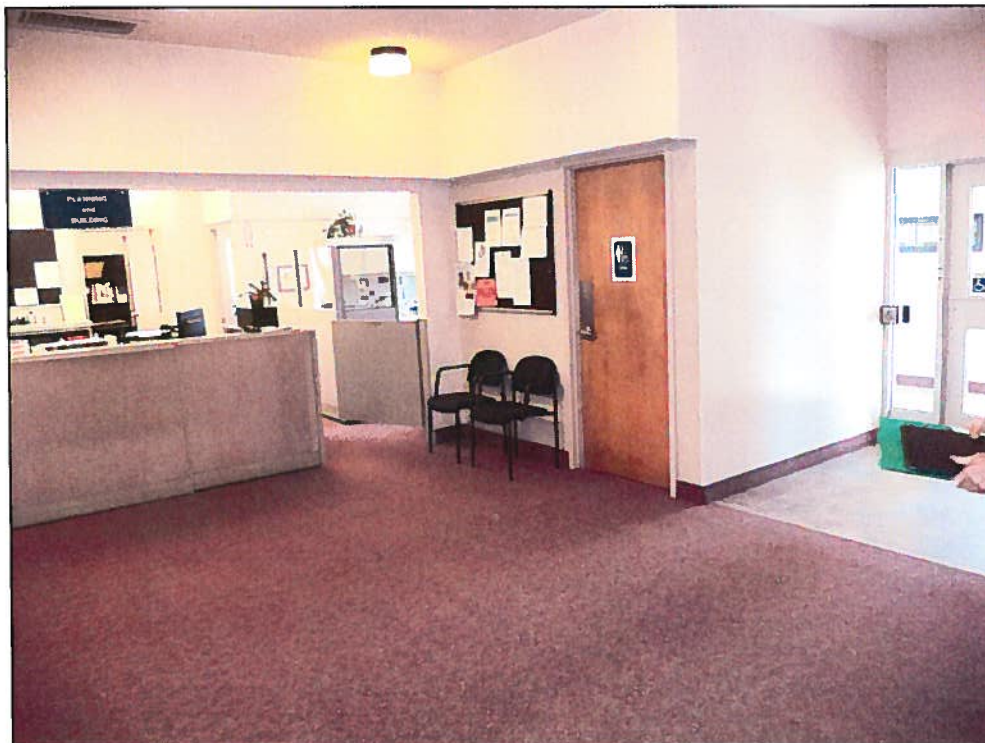
Photo 15 – The Image and Function of the Reception Area is Compromised and There is No Sense of a Public Lobby

Photo 16 - The Image and Function of the Reception Area is Compromised and There is No Sense of a Public Lobby

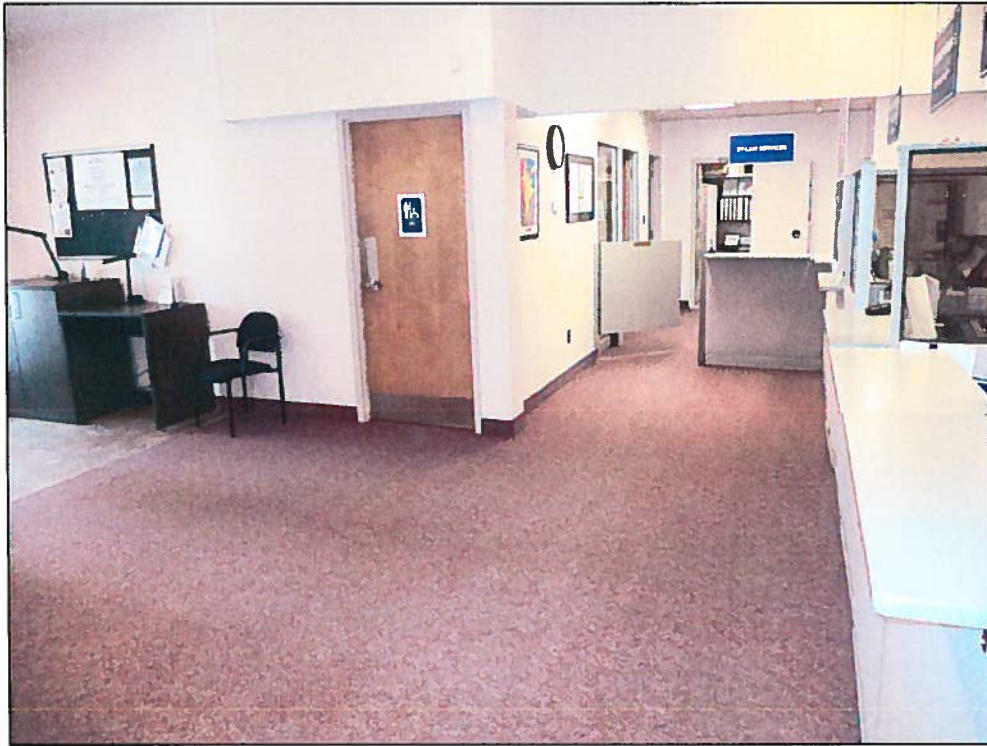
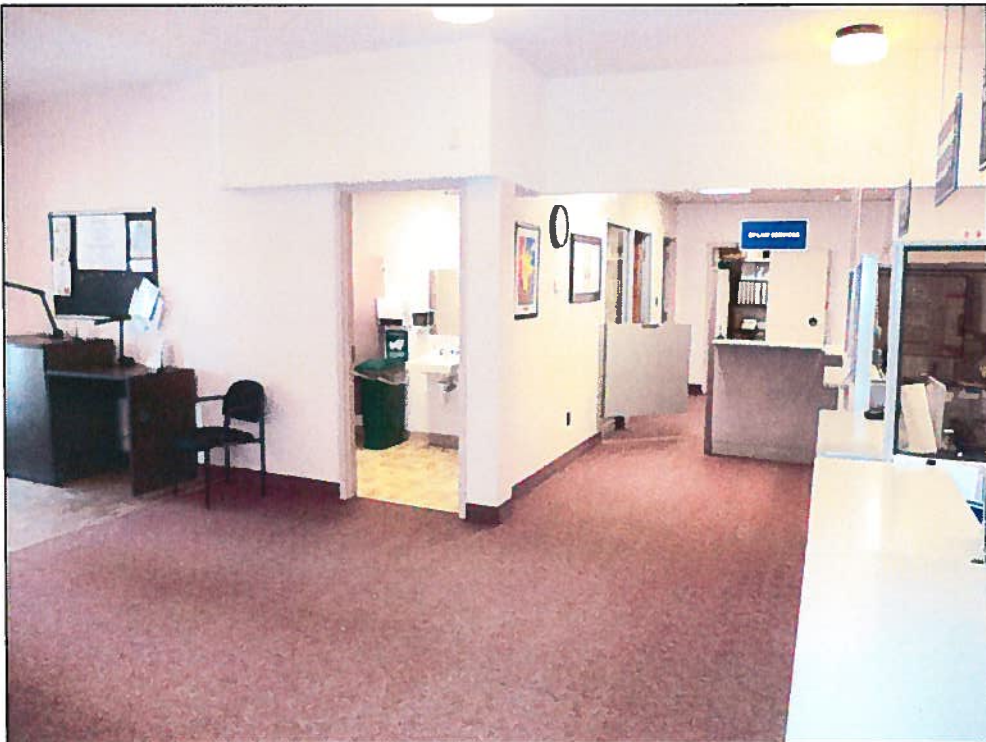
Photo 17 – The Public Washrooms are Located Too Close to the Front Counter

Photo 18 – The Public Washrooms are Located Too Close to the Front Counter

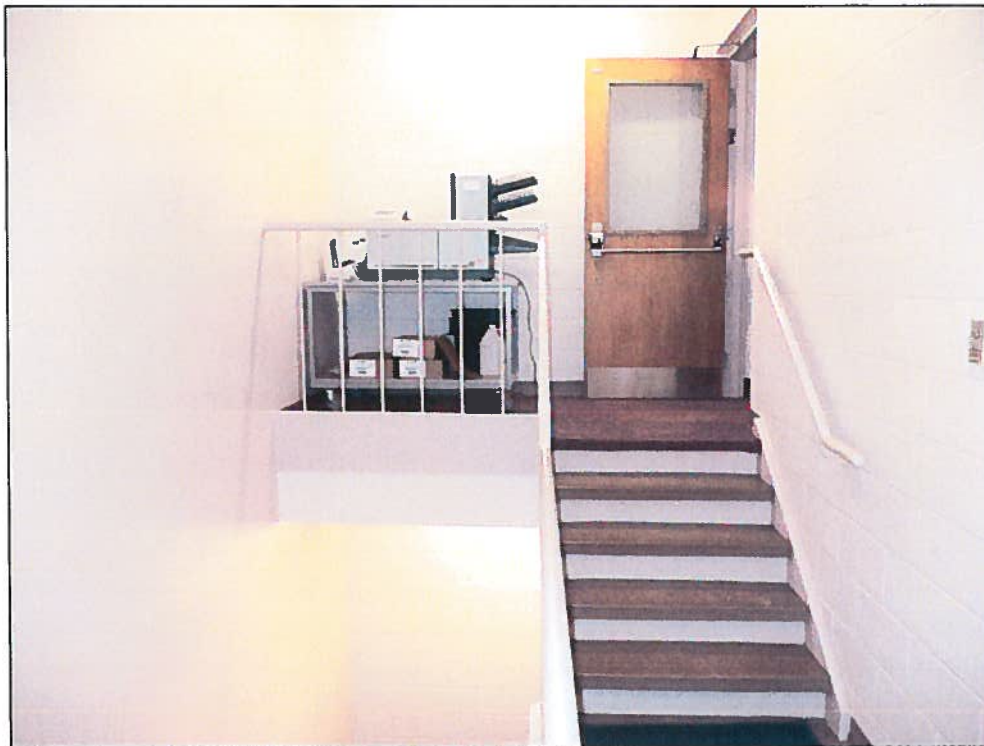
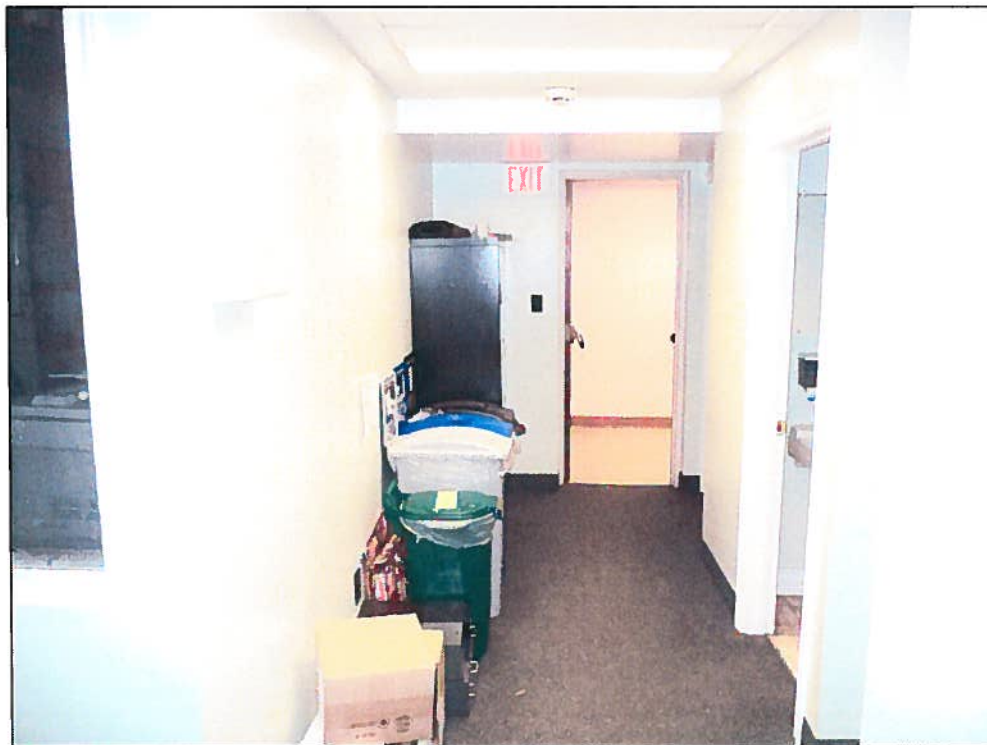
Photo 19 – Due to Lack of Functional Storage Space, Corridors are Used For Active Functions

Photo 20 – Due to Lack of Functional Storage Space, Corridors are Used For Active Functions
