**Township of Tiny
Municipal Administration Building
Needs Assessment Report**

**Report Update to Reflect
Present Office Conditions and
Proposed Construction Costs**

Original Report May 2014
Report Update January 2017

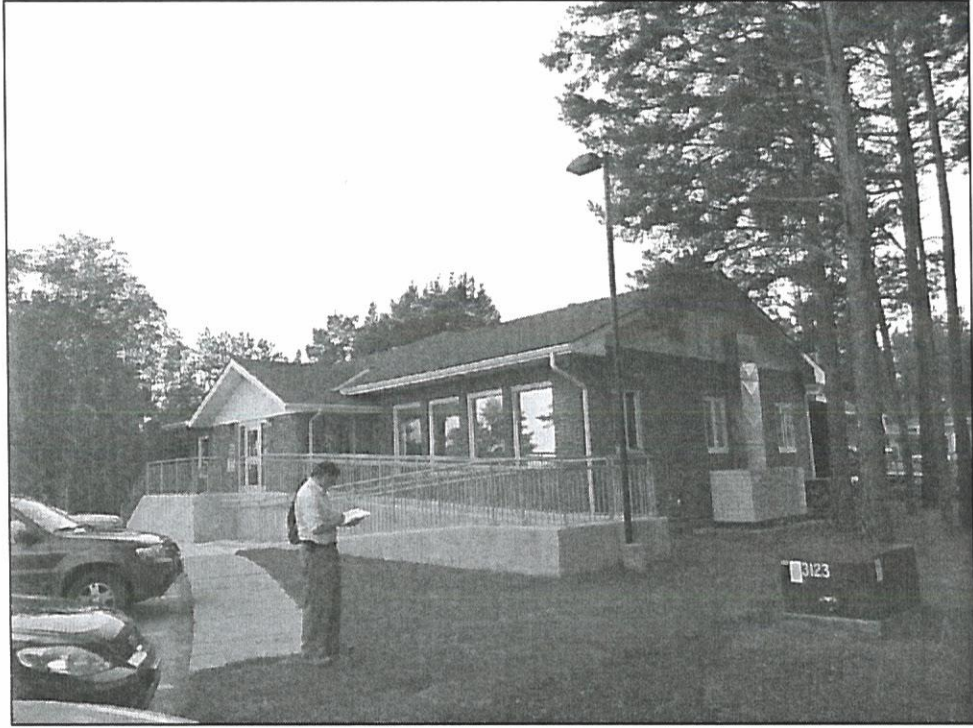
Photo 3 – Tiny Township Administration Building – South East Corner

1. Four fixed glass windows and 2 operable windows at the front (south) elevation of the original building require replacement. They appear to be of metal clad wood construction. There was evidence of seal failure and moisture within the air space between panes of glass. The other windows at this face of the building appear to have been recently replaced. See Photo 3, Appendix A.

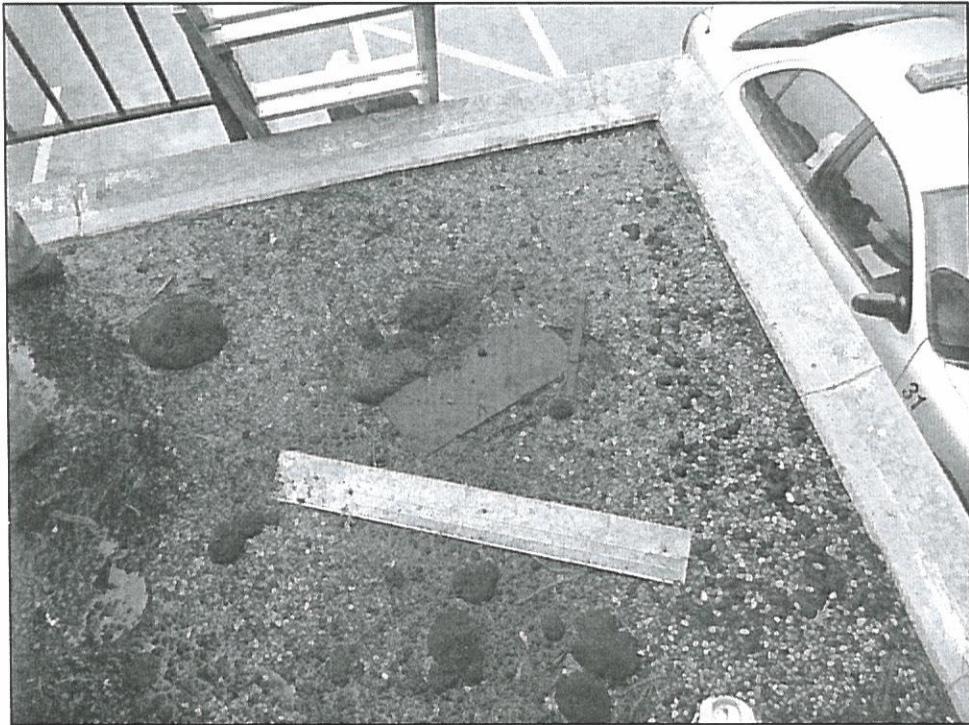
3. The flat roof over the Septic Inspector's office is retaining water and showing signs of organic growth (i.e. moss). Considering its age, this roof will require replacement within 5 years. See Photo 4, Appendix A.

Photo 4 – Flat Roof Over Septic Inspector's Office

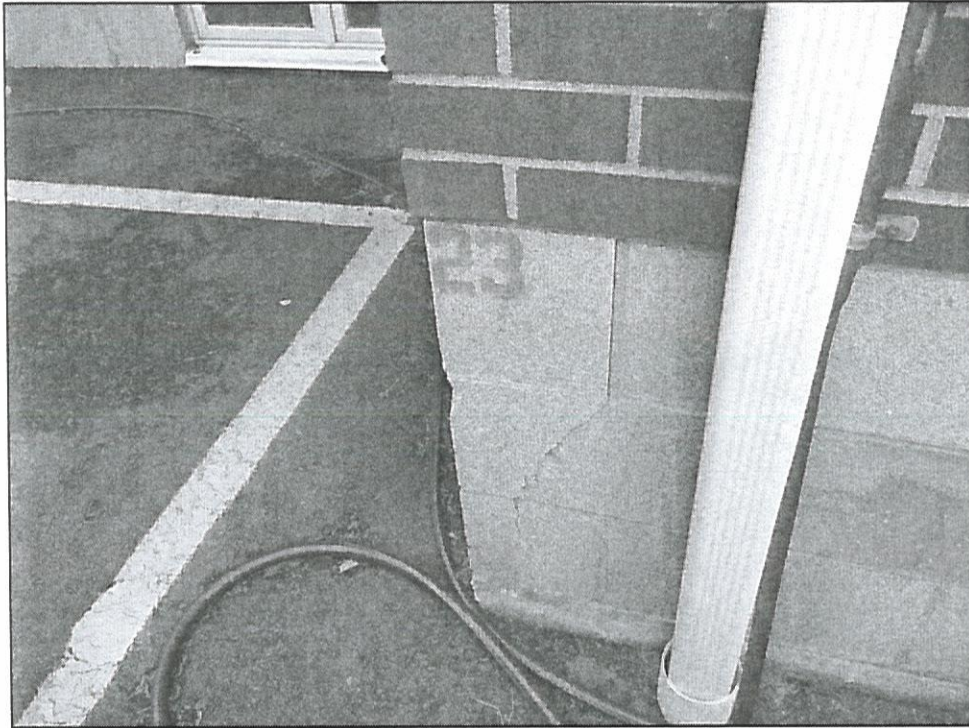
4. The foundation of the original building is of concrete block construction. It is in good condition with no evidence of damage except for the northwest corner where corner spalling has occurred. See Photo 5, Appendix A.

Photo 5 – Corner Spalling at Foundation of the Original Building

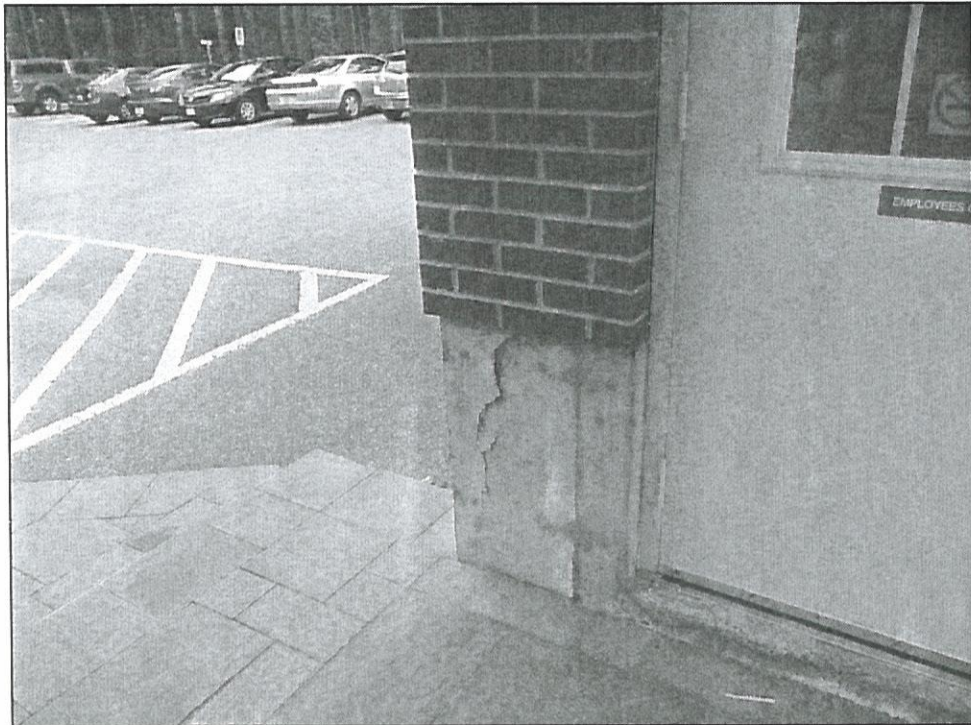
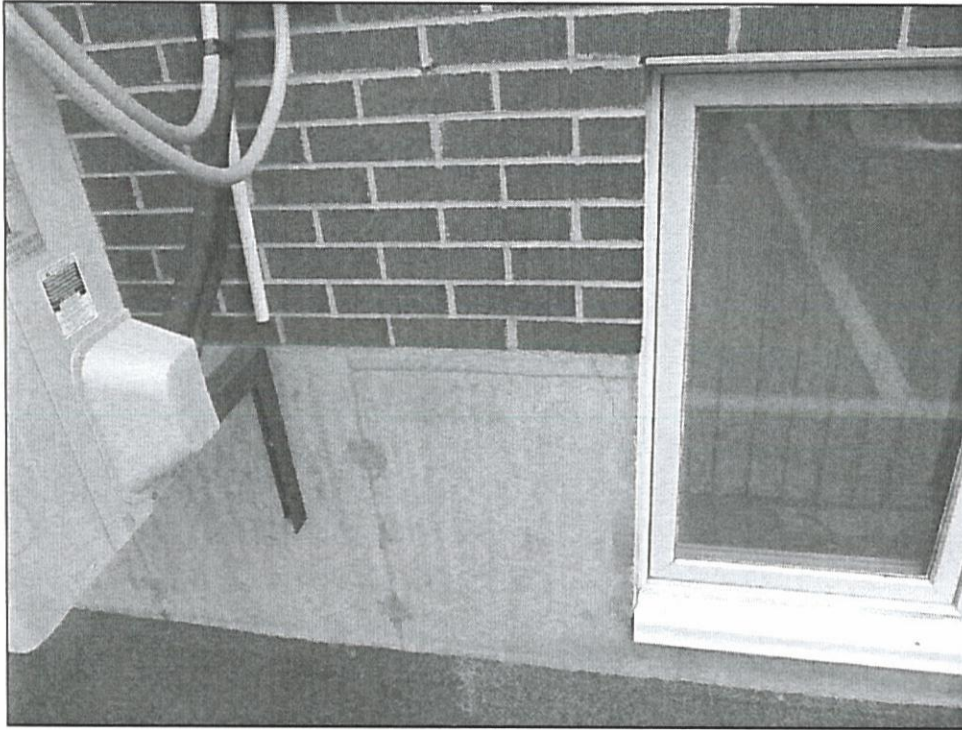
5. The foundation of the addition is of cast-in-place concrete construction. It is in very good condition with no evidence of damage except for localized spalling at the northeast corner of the addition and minor cracking at the side of one basement window on the west wall. See Photos 6 and 7, Appendix A.

Photo 6 – Corner Spalling on Southeast Corner on Addition Foundation

Photo 7 – Minor Cracking Beside One Basement Window on North side of Addition

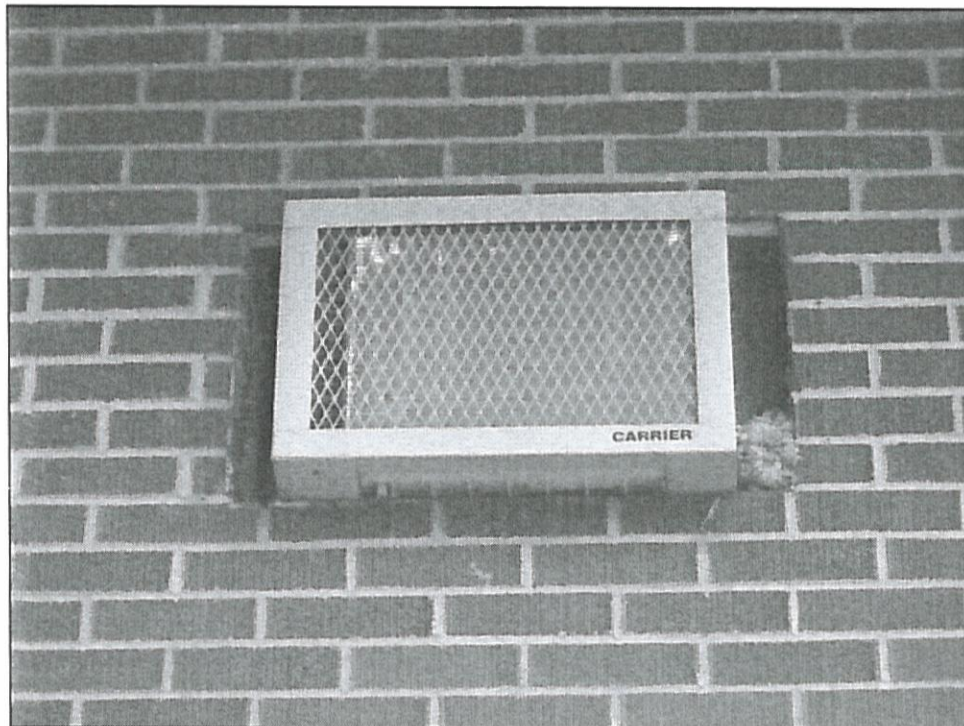
6. There is an oversized opening at the ground floor air conditioning unit near the northwest corner of the addition. The opening requires infilling to prevent entry of precipitation, birds, insects, etc. See Photo 8, Appendix A.

Photo 8 – Oversized Opening at Ground Floor AC Near Northeast Corner of Addition

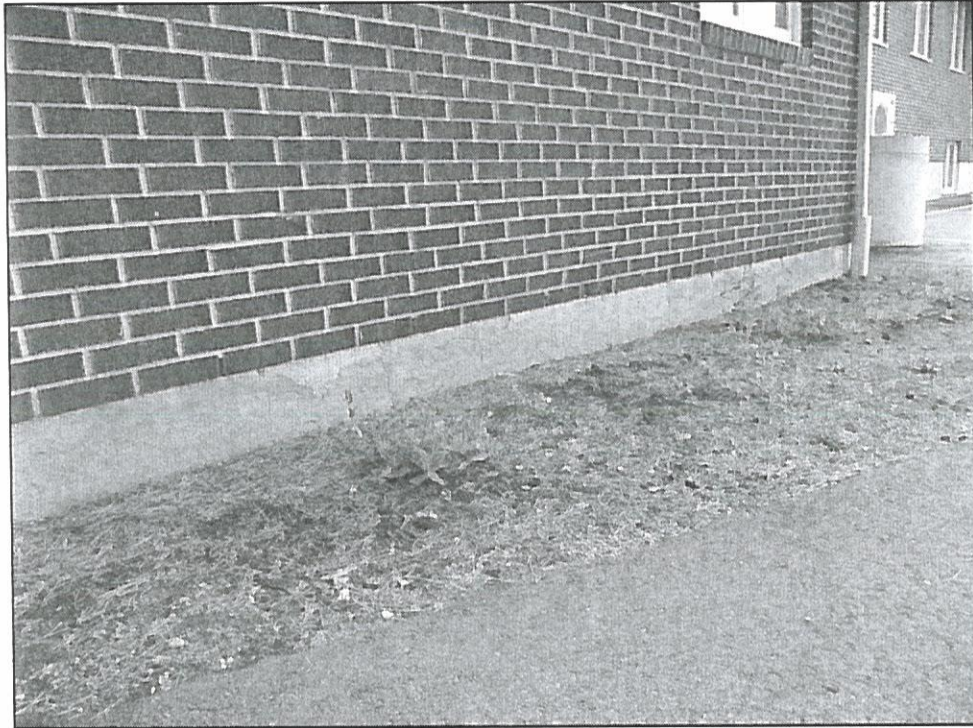
7. There is an Entrance Lobby at the northeast corner of the addition which provides barrier free access to the lower level Council Chamber. The foundation is of concrete block construction and exhibited evidence of cracking at the top course head joints in the mortar.

Photo 9 – Cracking at Top Course Head Joints of Concrete Block Foundation, Entrance Lobby at Northeast Corner of Addition

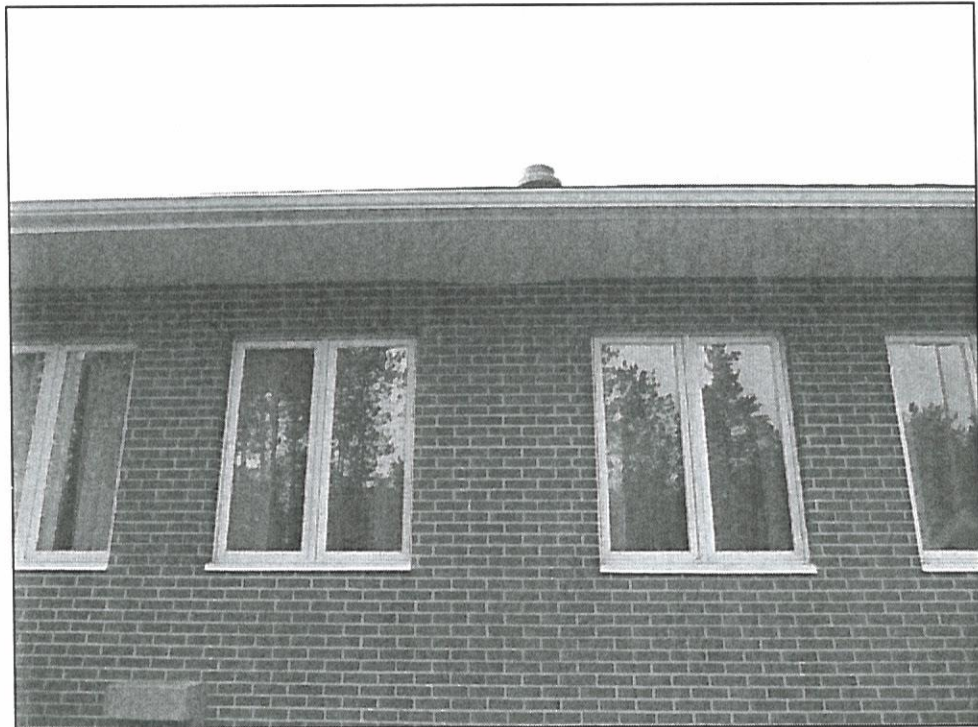
8. There was a 3 foot section of damaged soffit at the east side of the addition.
9. The finished grade along some sections of the original building foundation is above the level of the bricks. Although this is not good construction practice, there were no signs of damage to the brick.

Photo 10 – Three Foot Section of Damages Soffit at South Side of the Addition

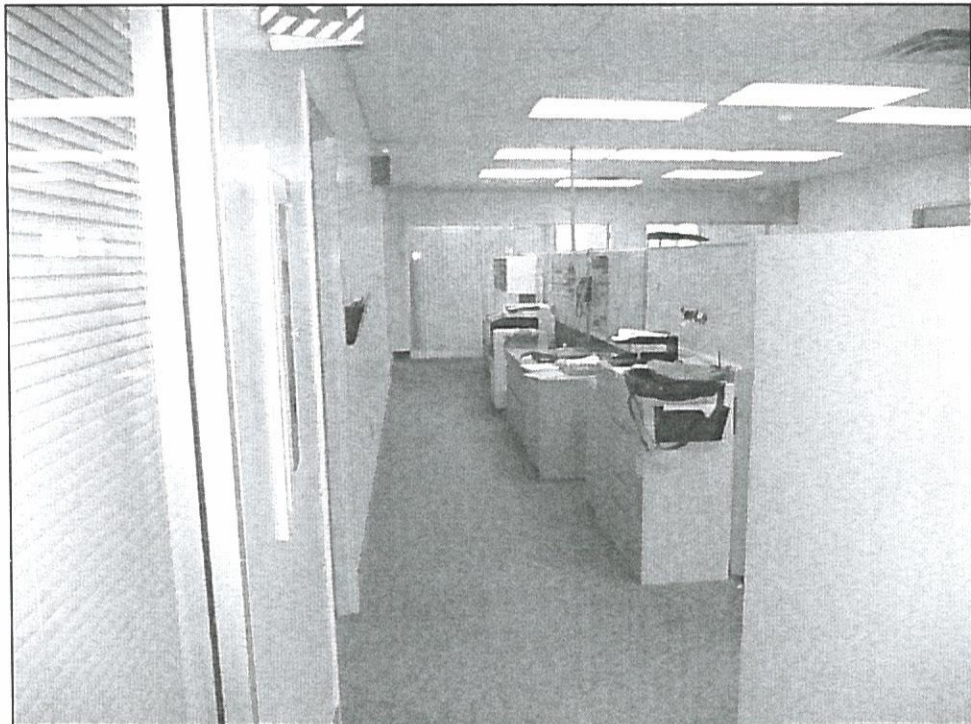
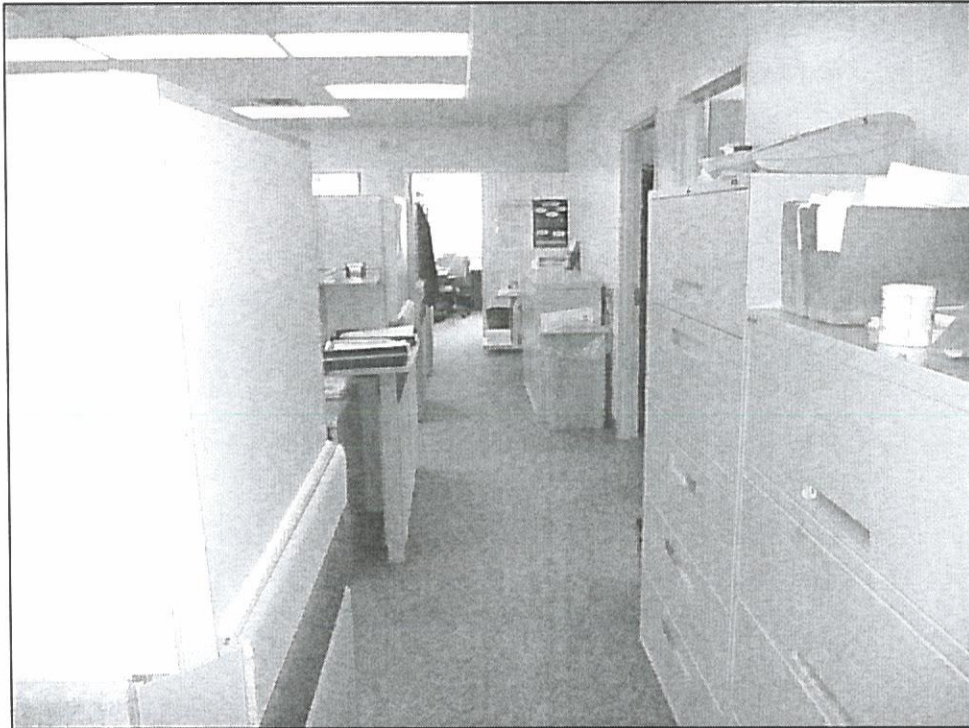
Photo 12 – The Location of Filing Cabinets in Corridor Areas is Such that They Infringe on Floor Space, Which Hampers the Operation of the Facility

Photo 13 – The Location of Filing Cabinets in Corridor Areas is Such that They Infringe on Floor Space, Which Hampers the Operation of the Facility

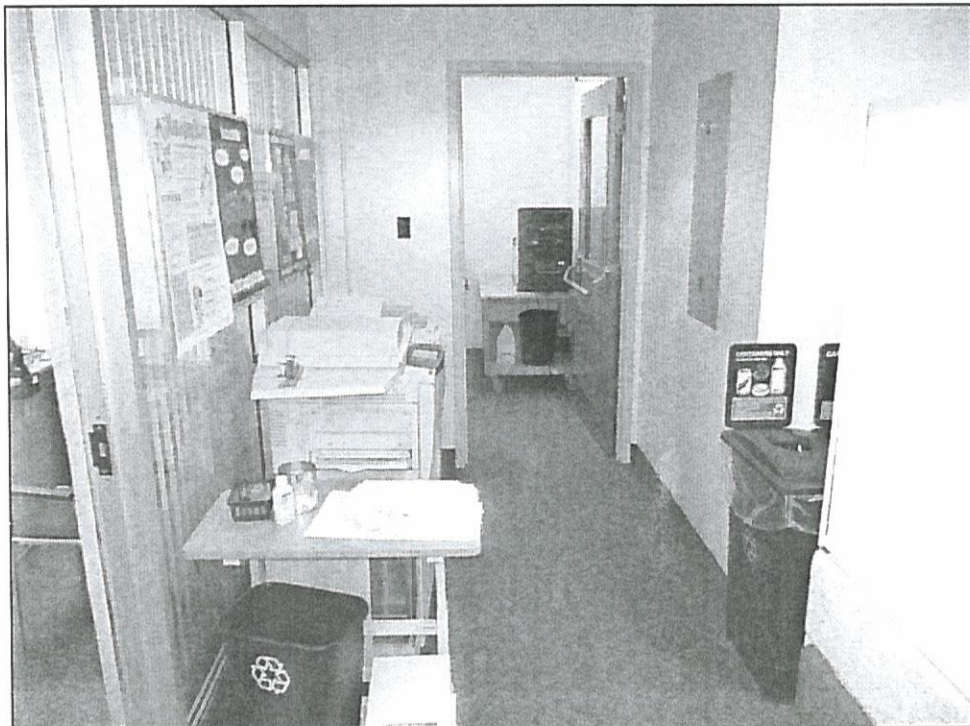
Photo 14 – The Location of Communal Printers and Correlation Services are Not Well Related to Users and Also Affects Means of Egress

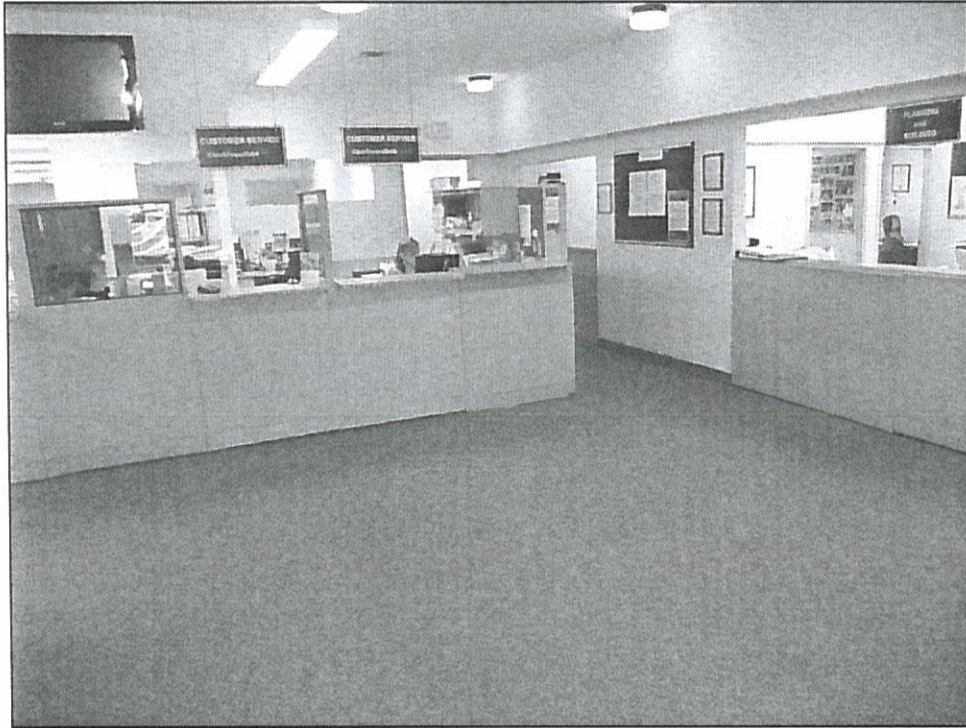
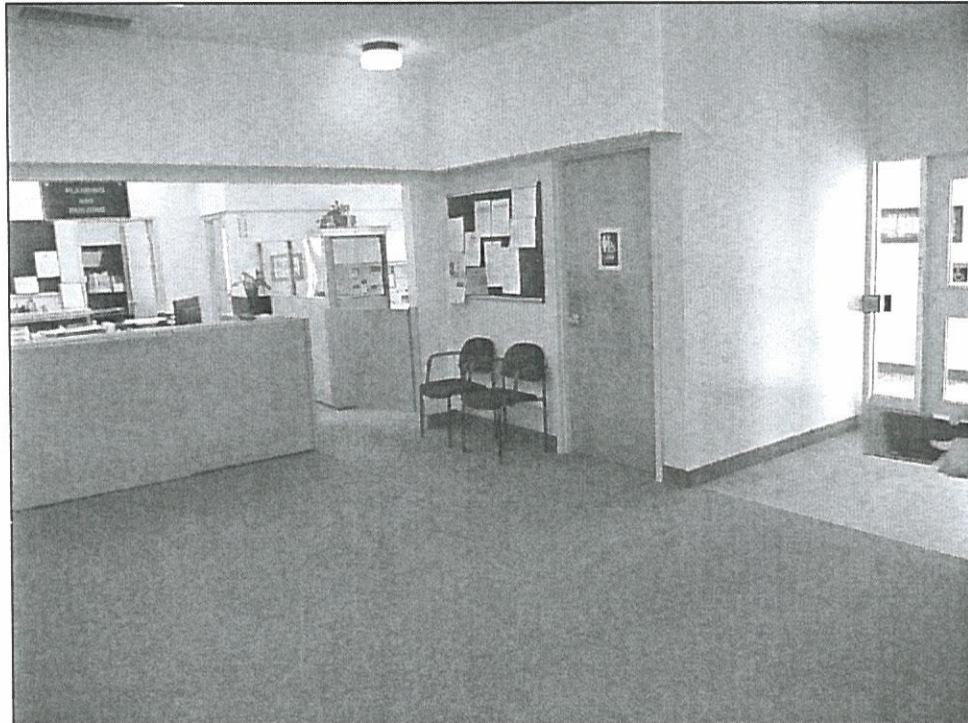
Photo 15 – The Image and Function of the Reception Area is Compromised and There is No Sense of a Public Lobby

Photo 16 - The Image and Function of the Reception Area is Compromised and There is No Sense of a Public Lobby

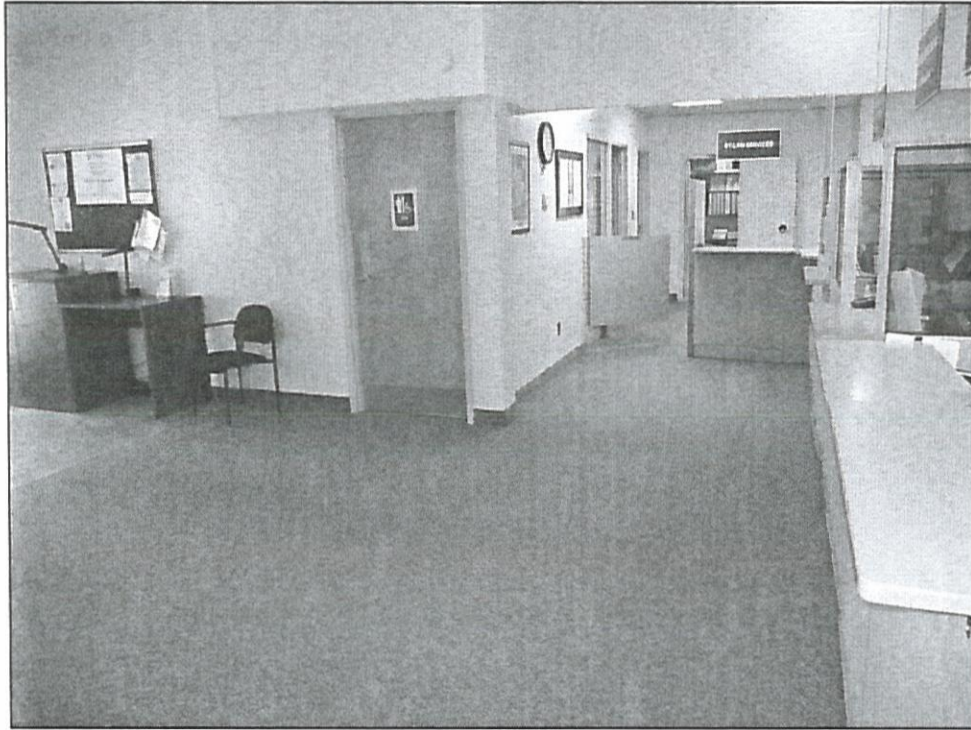
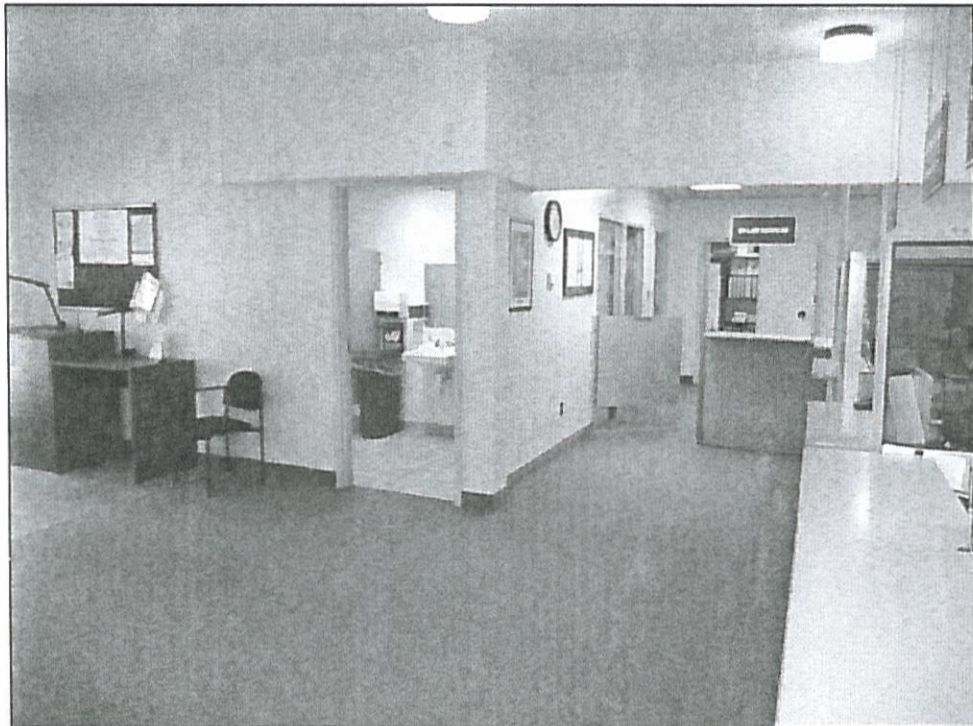
Photo 17 – The Public Washrooms are Located Too Close to the Front Counter

Photo 18 – The Public Washrooms are Located Too Close to the Front Counter

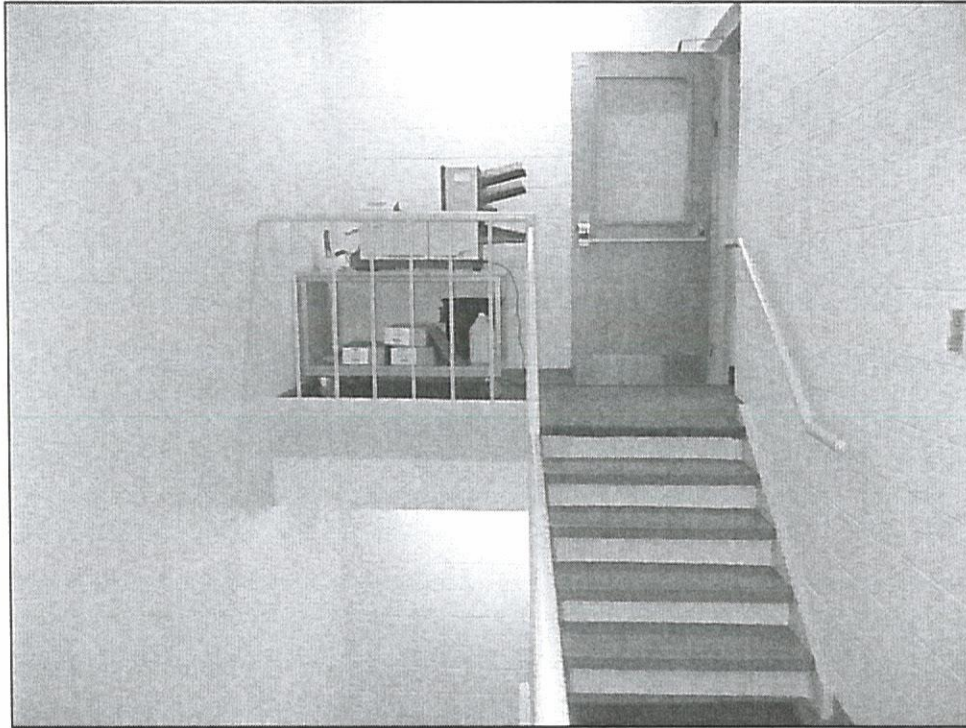
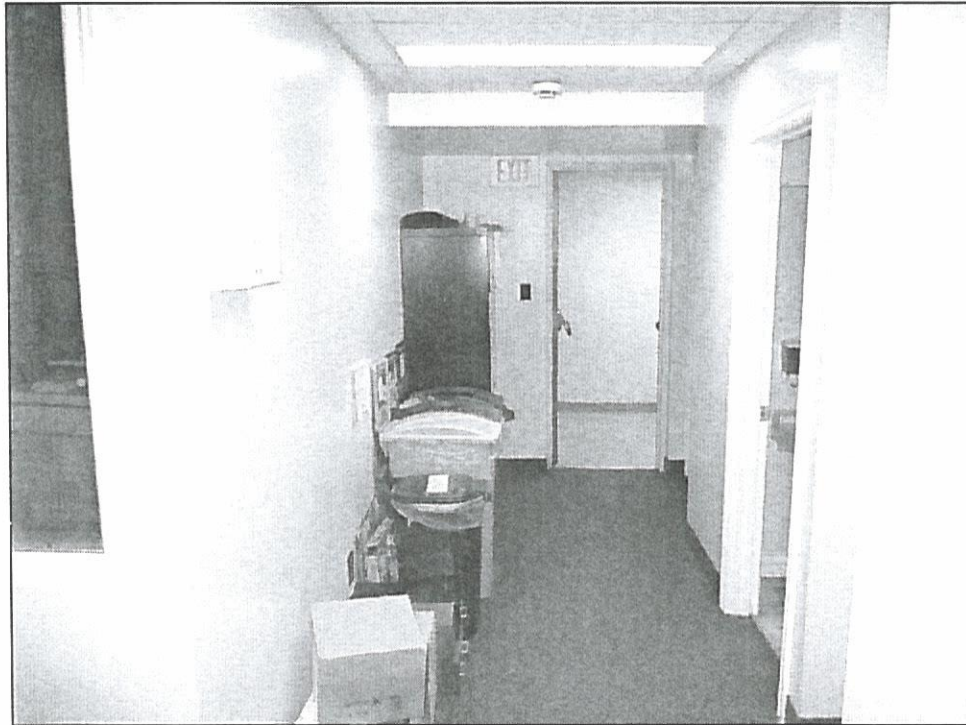
16. Building security is compromised with no barriers or impediments to prevent public from wandering through the building.
17. Due to lack of functional and storage space, corridors are used for active functions such as cheque processing and become repositories of combustible material representing a fire and exiting hazard (see photos 19 and 20).

Photo 19 – Due to Lack of Functional Storage Space, Corridors are Used For Active Functions

Photo 20 – Due to Lack of Functional Storage Space, Corridors are Used For Active Functions
