**RE: Natural Hazard Review  
Silver Birch Drive Properties, Tiny, ON  
Property Identification Numbers: 58424-0283  
58424-0206  
58424-0207  
58424-0208  
58424-0367**

**Our file: 25-4014**

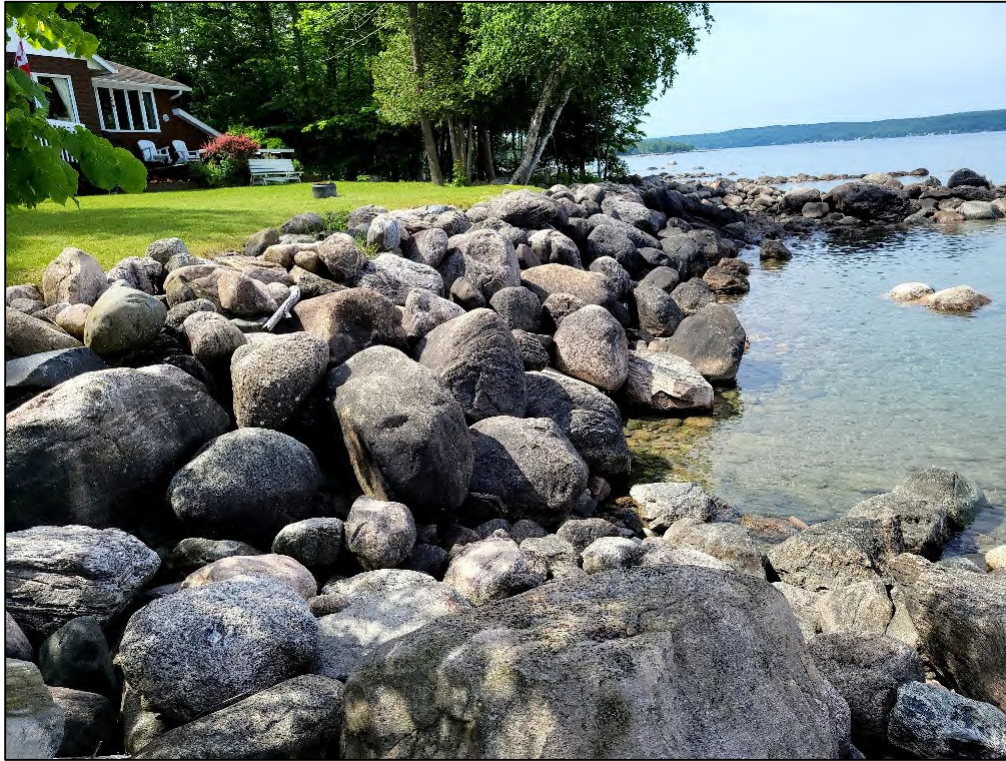
**Photo 1      Existing Revetment at Property 0283, June 2025**

fronting an existing cottage on property 0283. The revetment is constructed out of granite boulders with most of the boulders ranging in size from approximately 400mm to 1,000mm diameter. The revetment crest elevation was visually estimated to be in the order of 178.5m. It appears to be in good condition and functioning properly at current water levels.

Photo 1 shows the existing revetment at property 0283. Photo 2 and Photo 3, respectively, are northerly and southerly looking photos of the shoreline along the undeveloped properties. These were taken near the line between properties 0207 and 0208. Photo 4 shows large boulders along the treeline on property 0207.

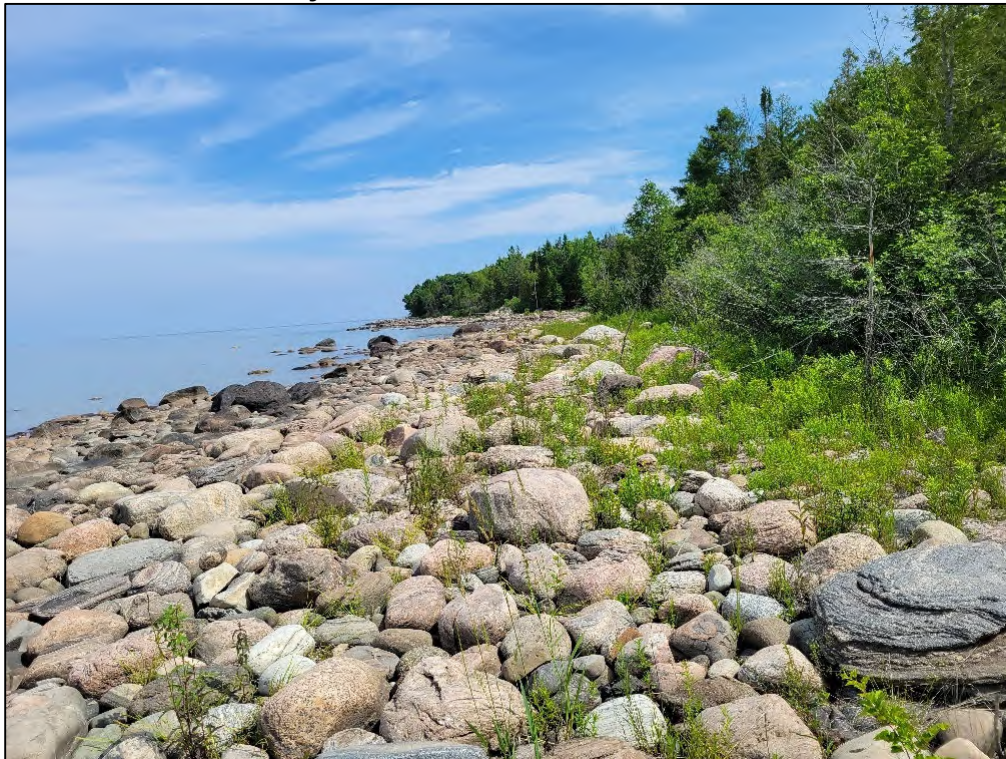
**Photo 2      Northerly View of Shoreline, June 2025**

The remaining properties are undeveloped. The controlling substrate is a cohesive till with a solid boulder pavement. Boulders along the water's edge are in the order of 400 to 800mm diameter. The boulder sizes reduce slightly to roughly 200 to 600mm diameter further inland and extend beyond the treeline. There are large boulders up to approximately 1.5m diameter scattered throughout the area.
