**Hydrogeological Assessment  
Sawlog Draft Plan**

**Township of Tiny, ON**

**October 2025  
300060798.0000**

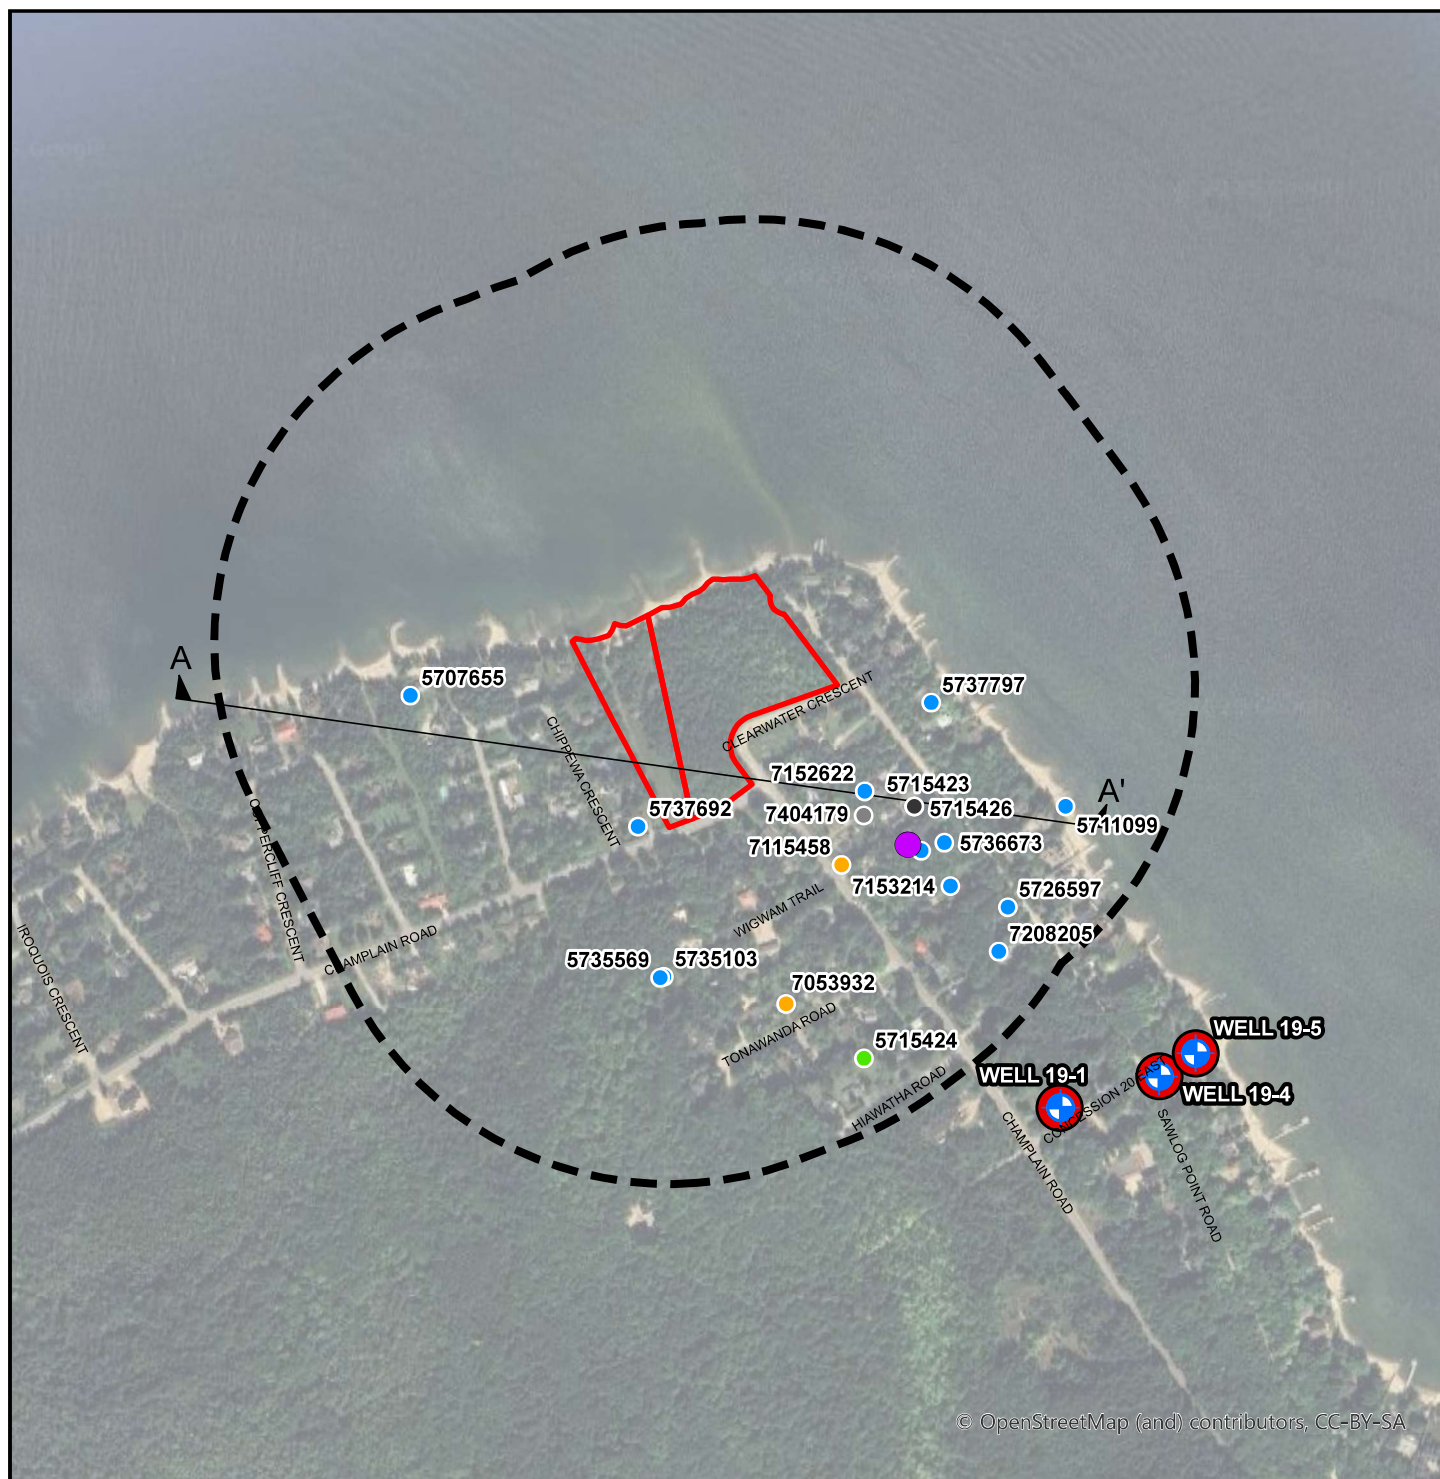
MECP water well records in the vicinity of the subject lands are mapped on Figure 5. The well locations are based on the UTM coordinates on the well records and have not been checked for accuracy. The MECP water well records were used to create one interpreted cross-section of the stratigraphy underlying the subject lands (Figure 6). The cross-section shows a layer of fine-grained sediments (till) of up to 17 m interbedded with coarse-grained sediments (sand and gravel) overlying limestone from Shadow Lake Formation. Granite is also present in most of the wells underlying limestone. The top of

The MECP maintains a database that provides geological records of wells drilled in the province. MECP well records in the vicinity of the subject lands are mapped on Figure 5. A review of MECP water well records within 500 m of the subject lands (Appendix A) identified 18 well records in which 13 are water supply wells, 2 are observation wells, 1 is a test hole and 2 are abandonment records. Out of the 13 water supply well records reviewed, 10 wells are completed in the bedrock (8 in granite and 2 in limestone) and 3 are completed in the overburden. Bedrock well depths range from 19.2 mbgl to 53.6 mbgl and overburden well depths range from 12.2 mbgl to 15.2 mbgl. Static water levels in the supply wells ranged from 2.7 mbgl to 20.1 mbgl in the granite, from 3.0 mbgl to 5.2 mbgl in the limestone, and from 4.9 mbgl to 8.7 mbgl in the overburden. Pumping test records indicate a low to moderate yield in the granite with recommended pumping rates ranging from 13.6 L/min (3 GPM) to 45.5 L/min (10 GPM). Limestone and overburden have slightly better yields with recommended pumping rates ranging from 22.7 L/min (5 GPM) to 36.4 L/min (8 GPM) and from 35 L/min (7.7 GPM) to 54.5 L/min (12 GPM), respectively.

With the permission of the owner, a raw water quality sample was collected from a drilled bedrock well located at 220 Sawlog Point Road on September 25, 2025. The well is approximately 200 m southeast of the subject lands (Figure 5) and has a reported depth of 103 m. Burnside was not permitted access into the house to collect the sample so provided instructions and laboratory supplied containers to the resident to collect the sample from their storage tank before the treatment systems. The samples were submitted to Bureau Veritas for analysis of general chemistry, metals, nutrients and microbiology. The analytical results are provided in Table C-1, Appendix C with comparison to the Ontario Drinking Water Quality Standards (ODWQS). The Certificate of Analysis provided by Bureau Veritas is also presented in Appendix C.
