**Township of Tiny
Municipal Administration Building
Needs Assessment Report**

R.J. Burnside & Associates Limited
3 Ronell Crescent Collingwood ON L9Y 4J6
and
Ted Handy and Associates Inc., Architect
76 Mary Street, Barrie ON L4N 1T1

May 2014

File No: 300033158.0000

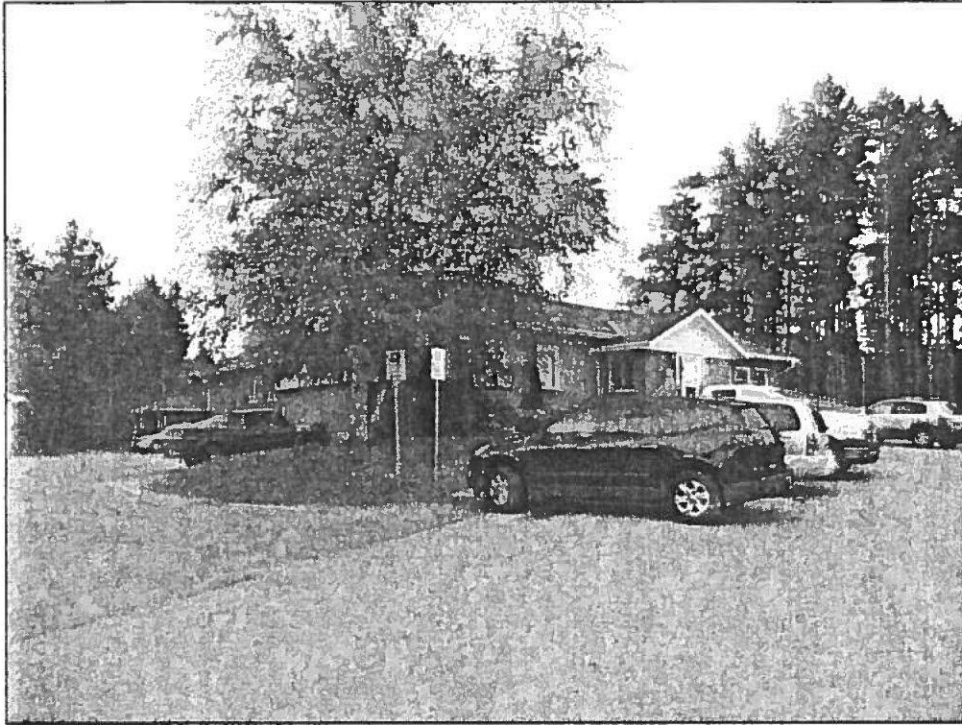
The Tiny Township Administration Building is located at 130 Balm Beach Road West, Perkinsfield. For the purposes of this report, the side of the building facing Balm Beach Road is considered the South elevation. See Photo 1, Appendix A.

Photo 1 – Tiny Township Administration Building – South West Corner

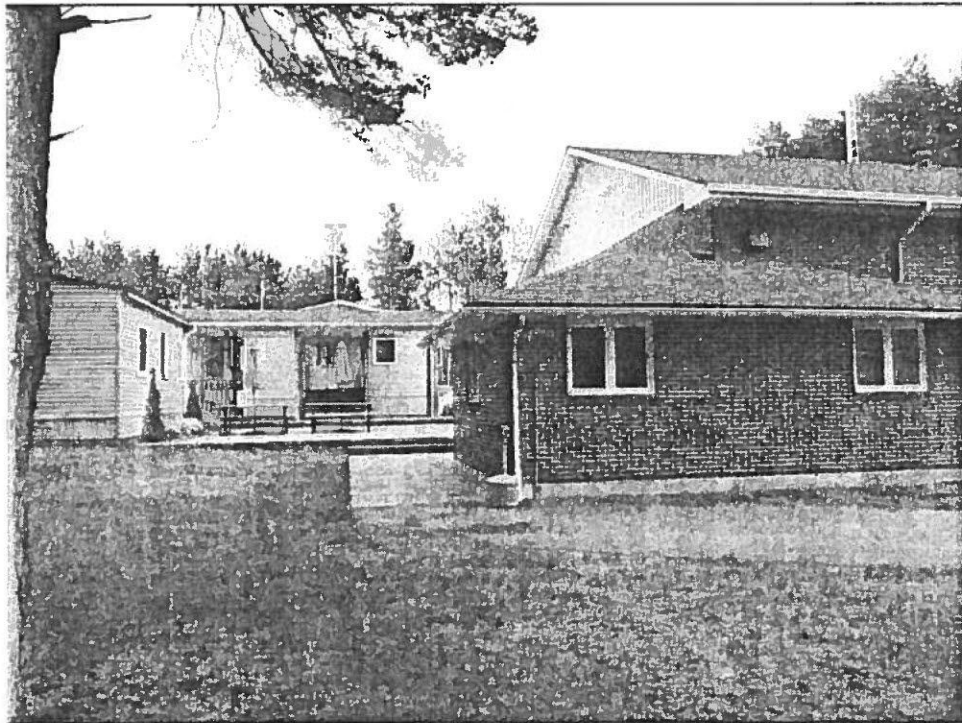
There are 2 temporary portable structures at the rear of the main building that are connected together by a canopy roof. See Photo 2, Appendix A.

Photo 2 – Two Temporary Portable Structures at Rear of Addition

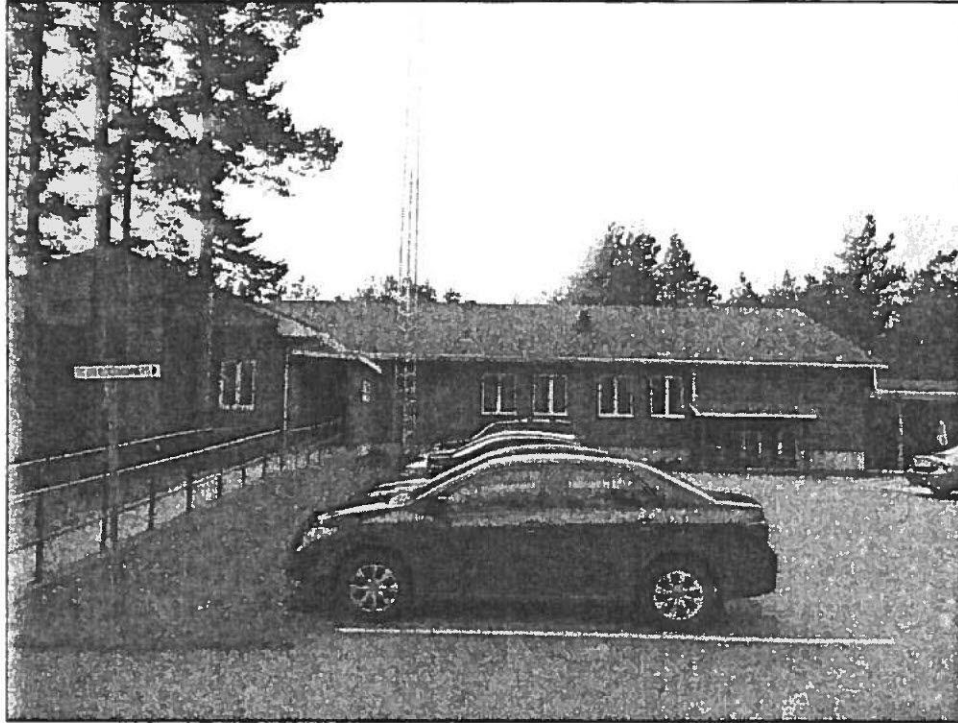
Barrier-free accessibility to the Council Chamber at the north half of the basement is provided via a stair lift at the northwest corner of the building. There is no other barrier-free access to the lower level. Barrier free access to the first floor is via a ramp at the main entrance to the building on the south side and a secondary brick paved ramp at the east side. See Photo 11, Appendix A.

Photo 11 – Brick Paved Ramp at South Side of Building
