Township of Tiny Municipal Administration Building

Needs Assessment Report

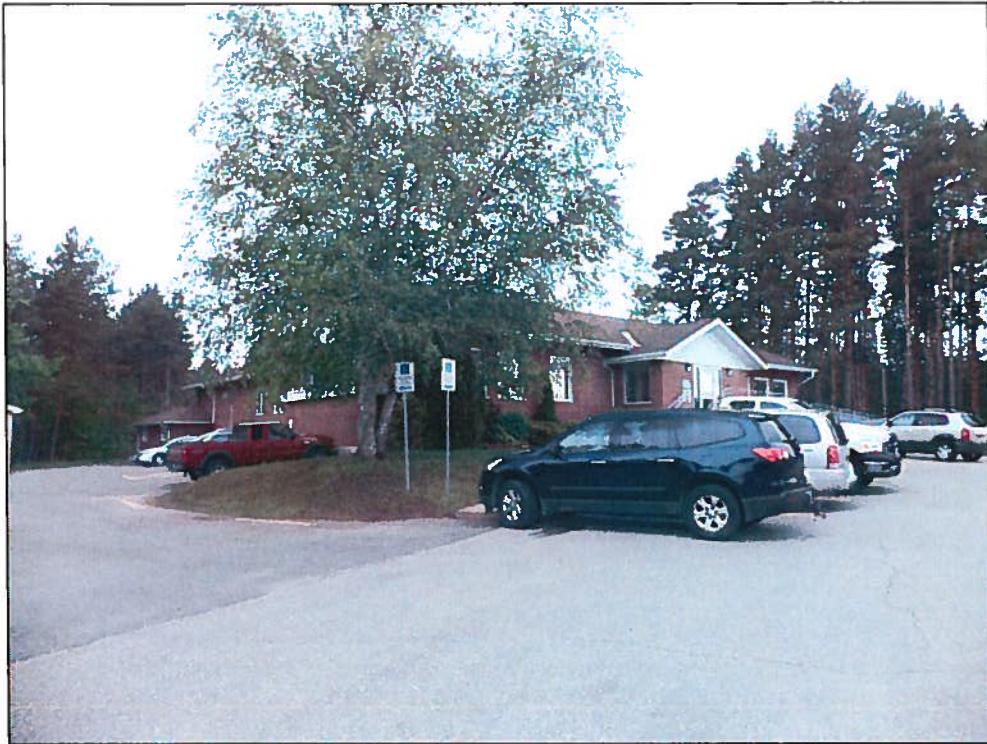
Photo 1 – Tiny Township Administration Building – South West Corner

The Tiny Township Administration Building is located at 130 Balm Beach Road West, Perkinsfield. For the purposes of this report, the side of the building facing Balm Beach Road is considered the South elevation. See Photo 1, Appendix A.

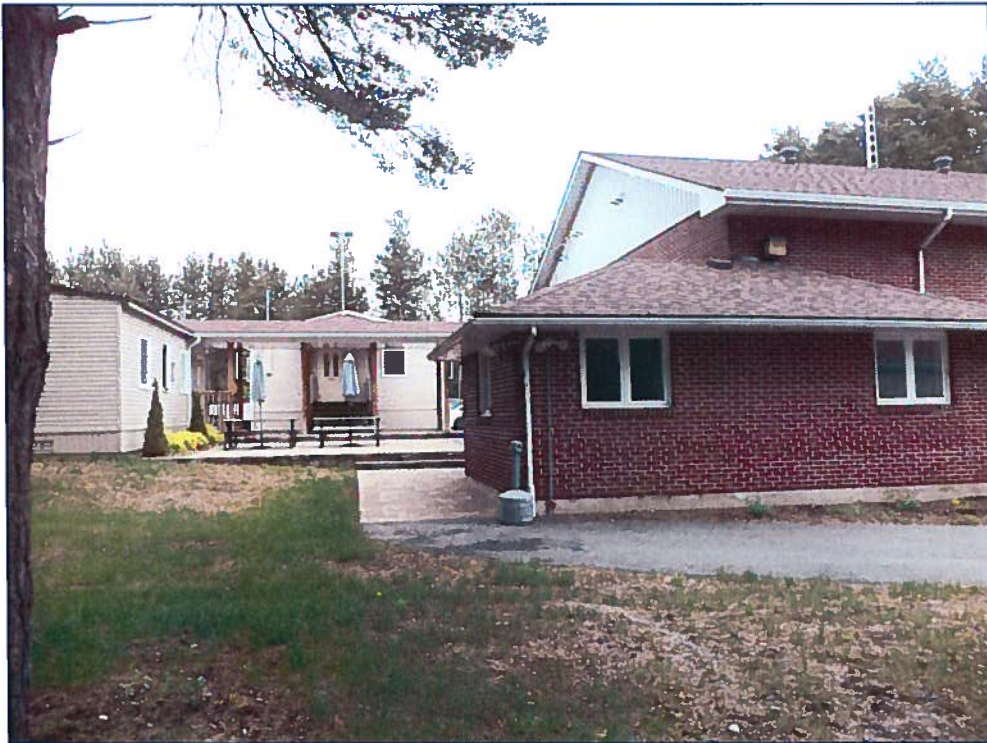
Photo 2 – Two Temporary Portable Structures at Rear of Addition

There are 2 temporary portable structures at the rear of the main building that are connected together by a canopy roof. See Photo 2, Appendix A.

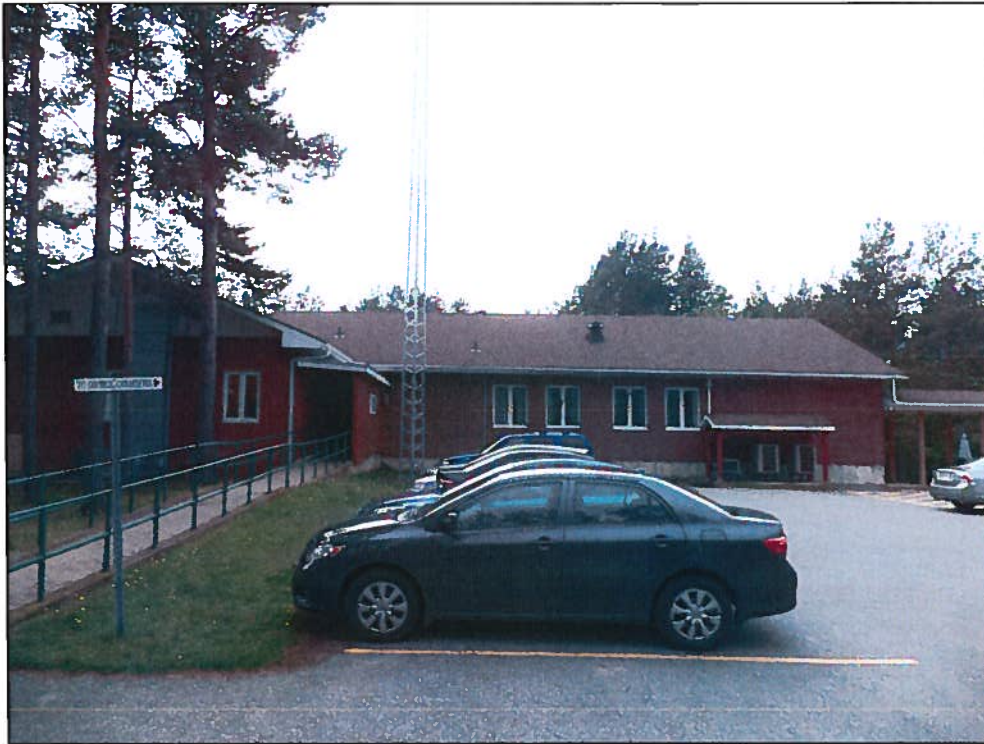
Photo 11 – Brick Paved Ramp at South Side of Building

Barrier-free accessibility to the Council Chamber at the north half of the basement is provided via a stair lift at the northwest corner of the building. There is no other barrier-free access to the lower level. Barrier free access to the first floor is via a ramp at the main entrance to the building on the south side and a secondary brick paved ramp at the east side. See Photo 11, Appendix A.
