**Township of Tiny
Municipal Administration Building
Needs Assessment Report**

**Report Update to Reflect
Present Office Conditions and
Proposed Construction Costs**

Original Report May 2014
Report Update January 2017

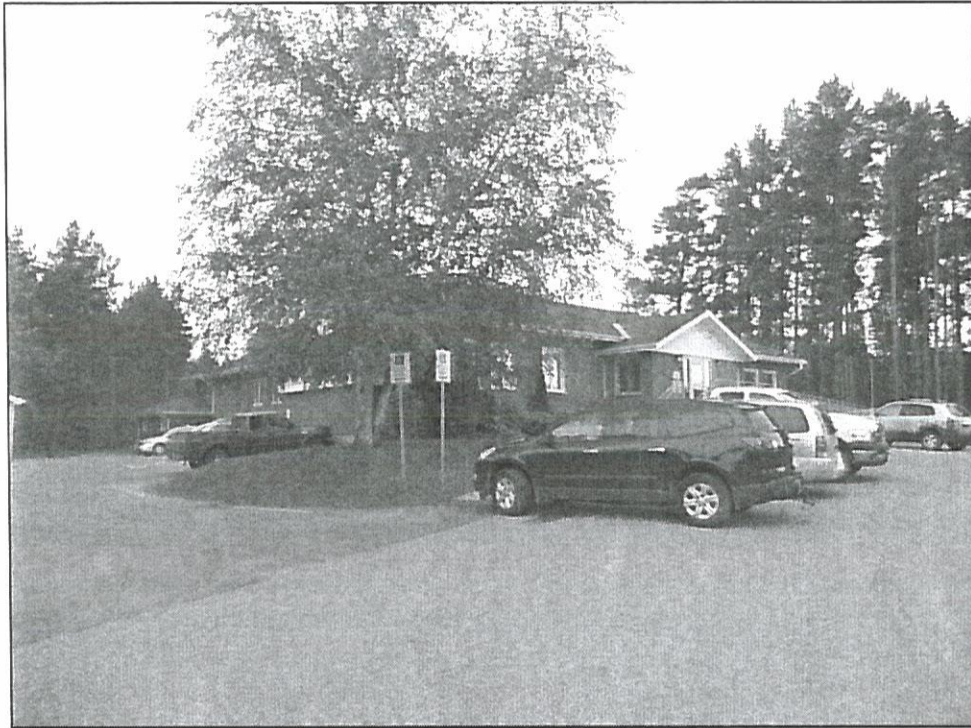
Photo 1 – Tiny Township Administration Building – South West Corner

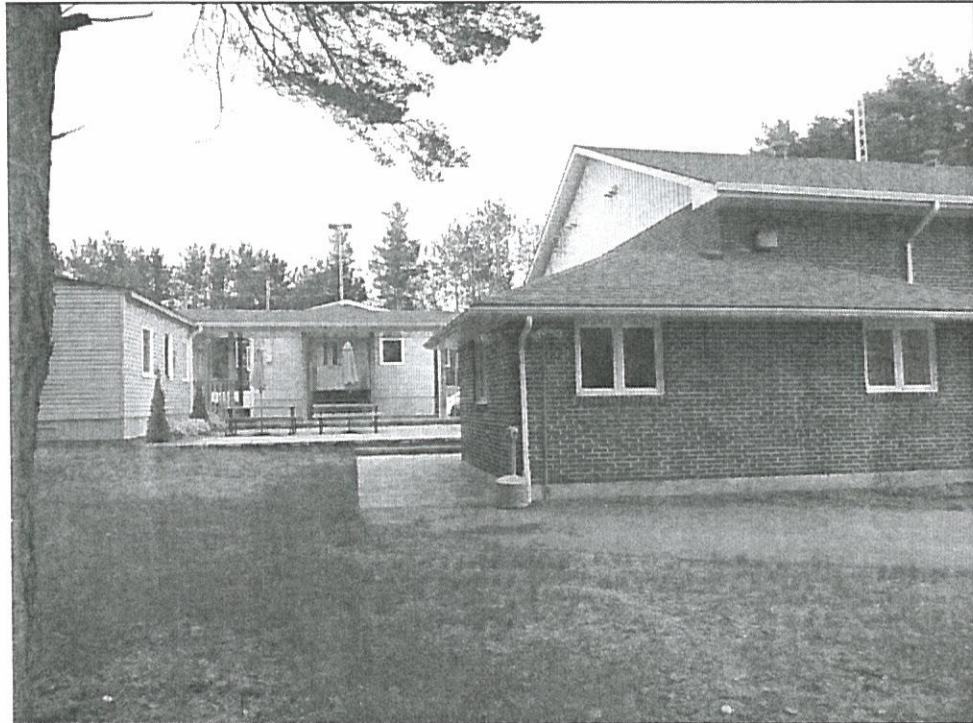
There are 2 temporary portable structures at the rear of the main building that are connected together by a canopy roof. See Photo 2, Appendix A.

Photo 2 – Two Temporary Portable Structures at Rear of Addition

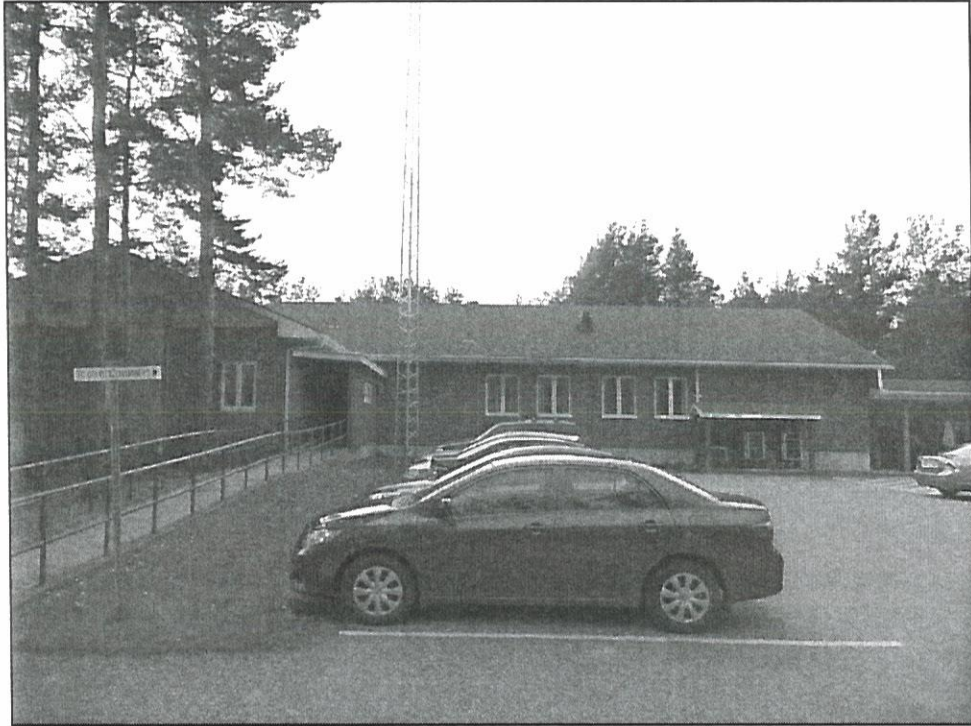
Barrier-free accessibility to the Council Chamber at the north half of the basement is provided via a stair lift at the northwest corner of the building. There is no other barrier-free access to the lower level. Barrier free access to the first floor is via a ramp at the main entrance to the building on the south side and a secondary brick paved ramp at the east side. See Photo 11, Appendix A.

Photo 11 – Brick Paved Ramp at South Side of Building
